Town Link Trail

Sitework Photopages

Following the construction of Phase II of the Town Link Trail in Charlotte, VT, Timber & Stone, LLC walked the trail with Dean Bloch to identify potential drainage challenges. In all, six specific locations were identified and discussed. Below is a summary of those findings, an estimate for addressing the issues is attached.

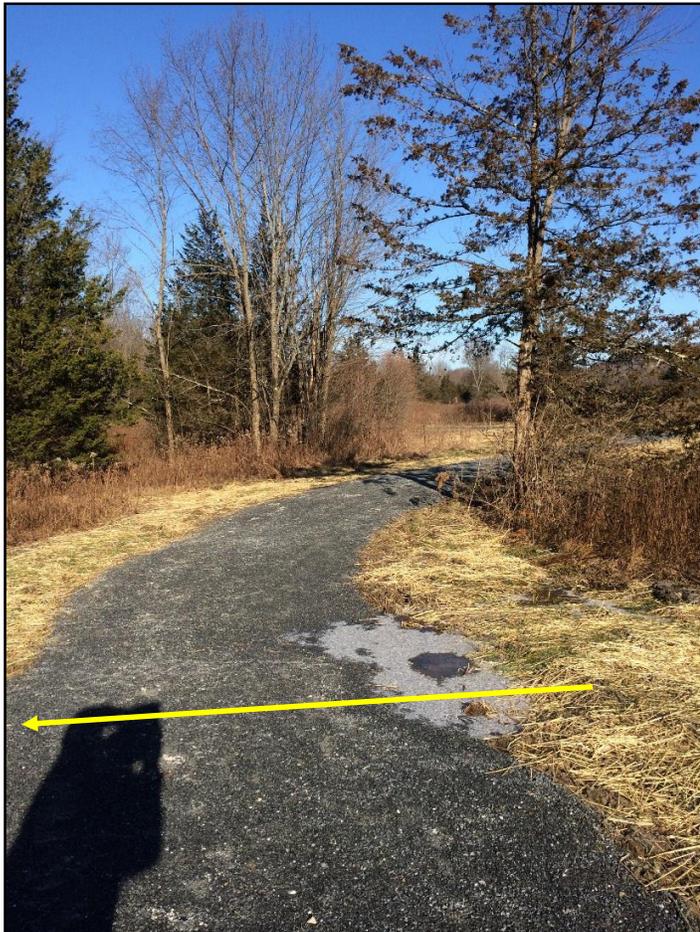
Site 2

Heading North towards Cohousing, this bend in the trail is exhibiting pooling of water from a seep that presented itself in the fall.

A culvert is needed to capture the water and adequately drain it on the left side of the trail.

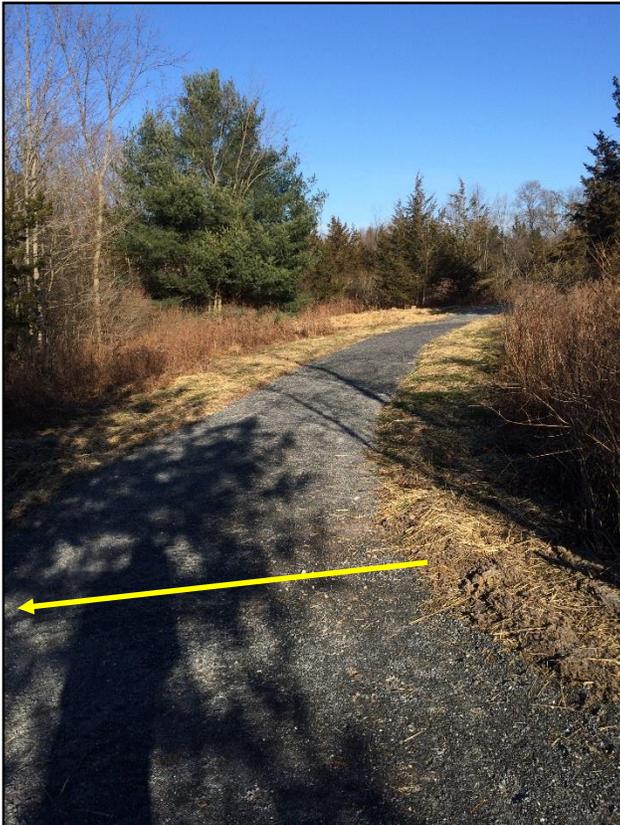
Site 3

Just after the gateway of a few Juniper trees, there appeared to be some staining on the surfacing where water was weeping across the tread right to left.

This area was identified as a place to monitor as the water did not seem to be running.

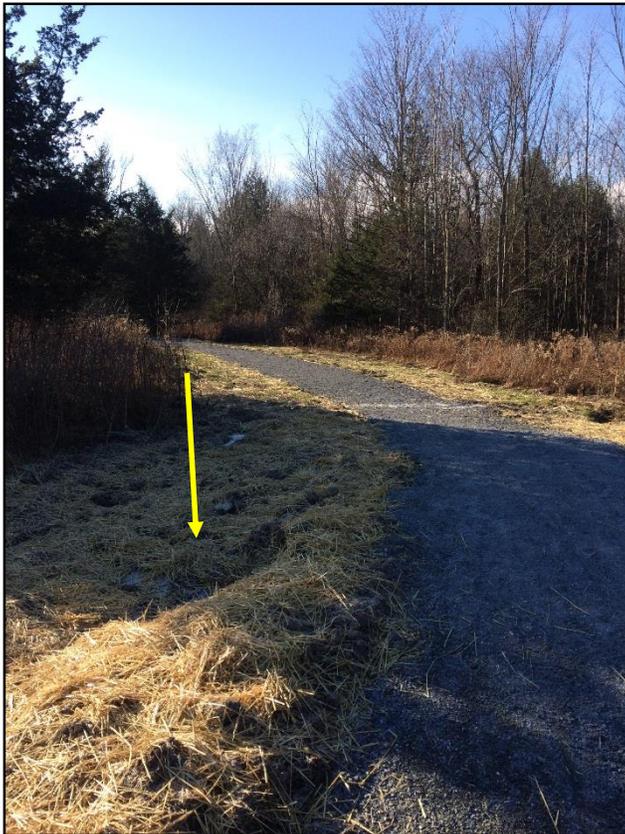
Site 4

This culvert entrance needs reshaping to ensure all water is being captured and delivered under the trail. By sculpting the opening of the culvert to direct all water under the tread, the additional seep at the top of the arrow will be directed into the culvert and not across the trail.

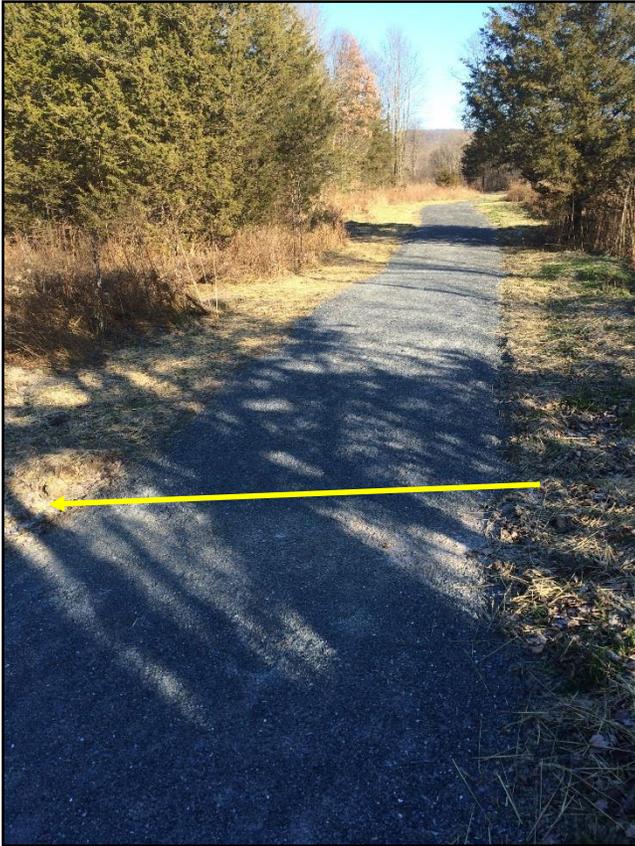
Site 5

This section was identified as a spot to keep an eye on the water as it weeps from right to left. Installing a cobble drain could be useful should the presence of water continue.

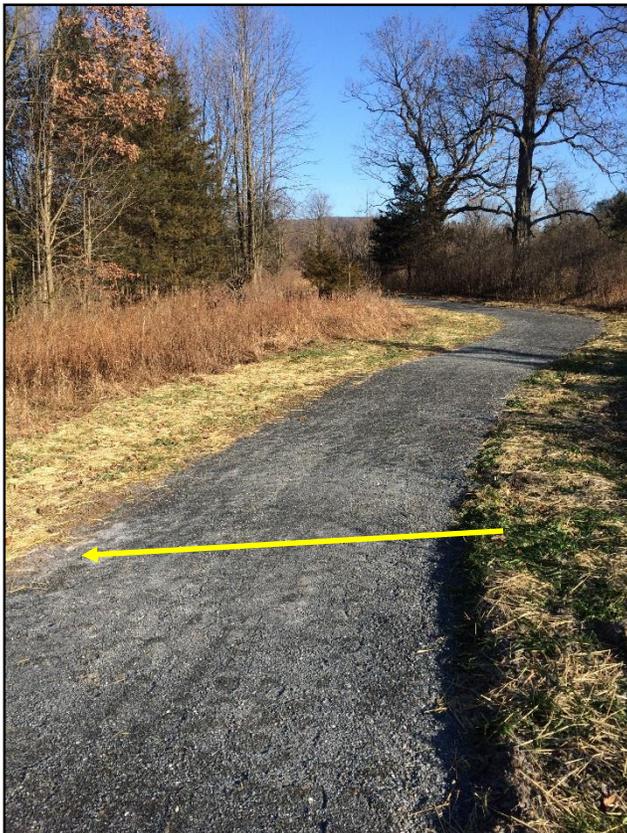
Site 6

This section was identified as a spot to keep an eye on the water as it weeps from right to left. Installing a cobble drain could be useful should the presence of water continue.
