Civil Engineering Associates, Inc.

January 3, 2014

Re: Town Hall/Library Green Drainage Study

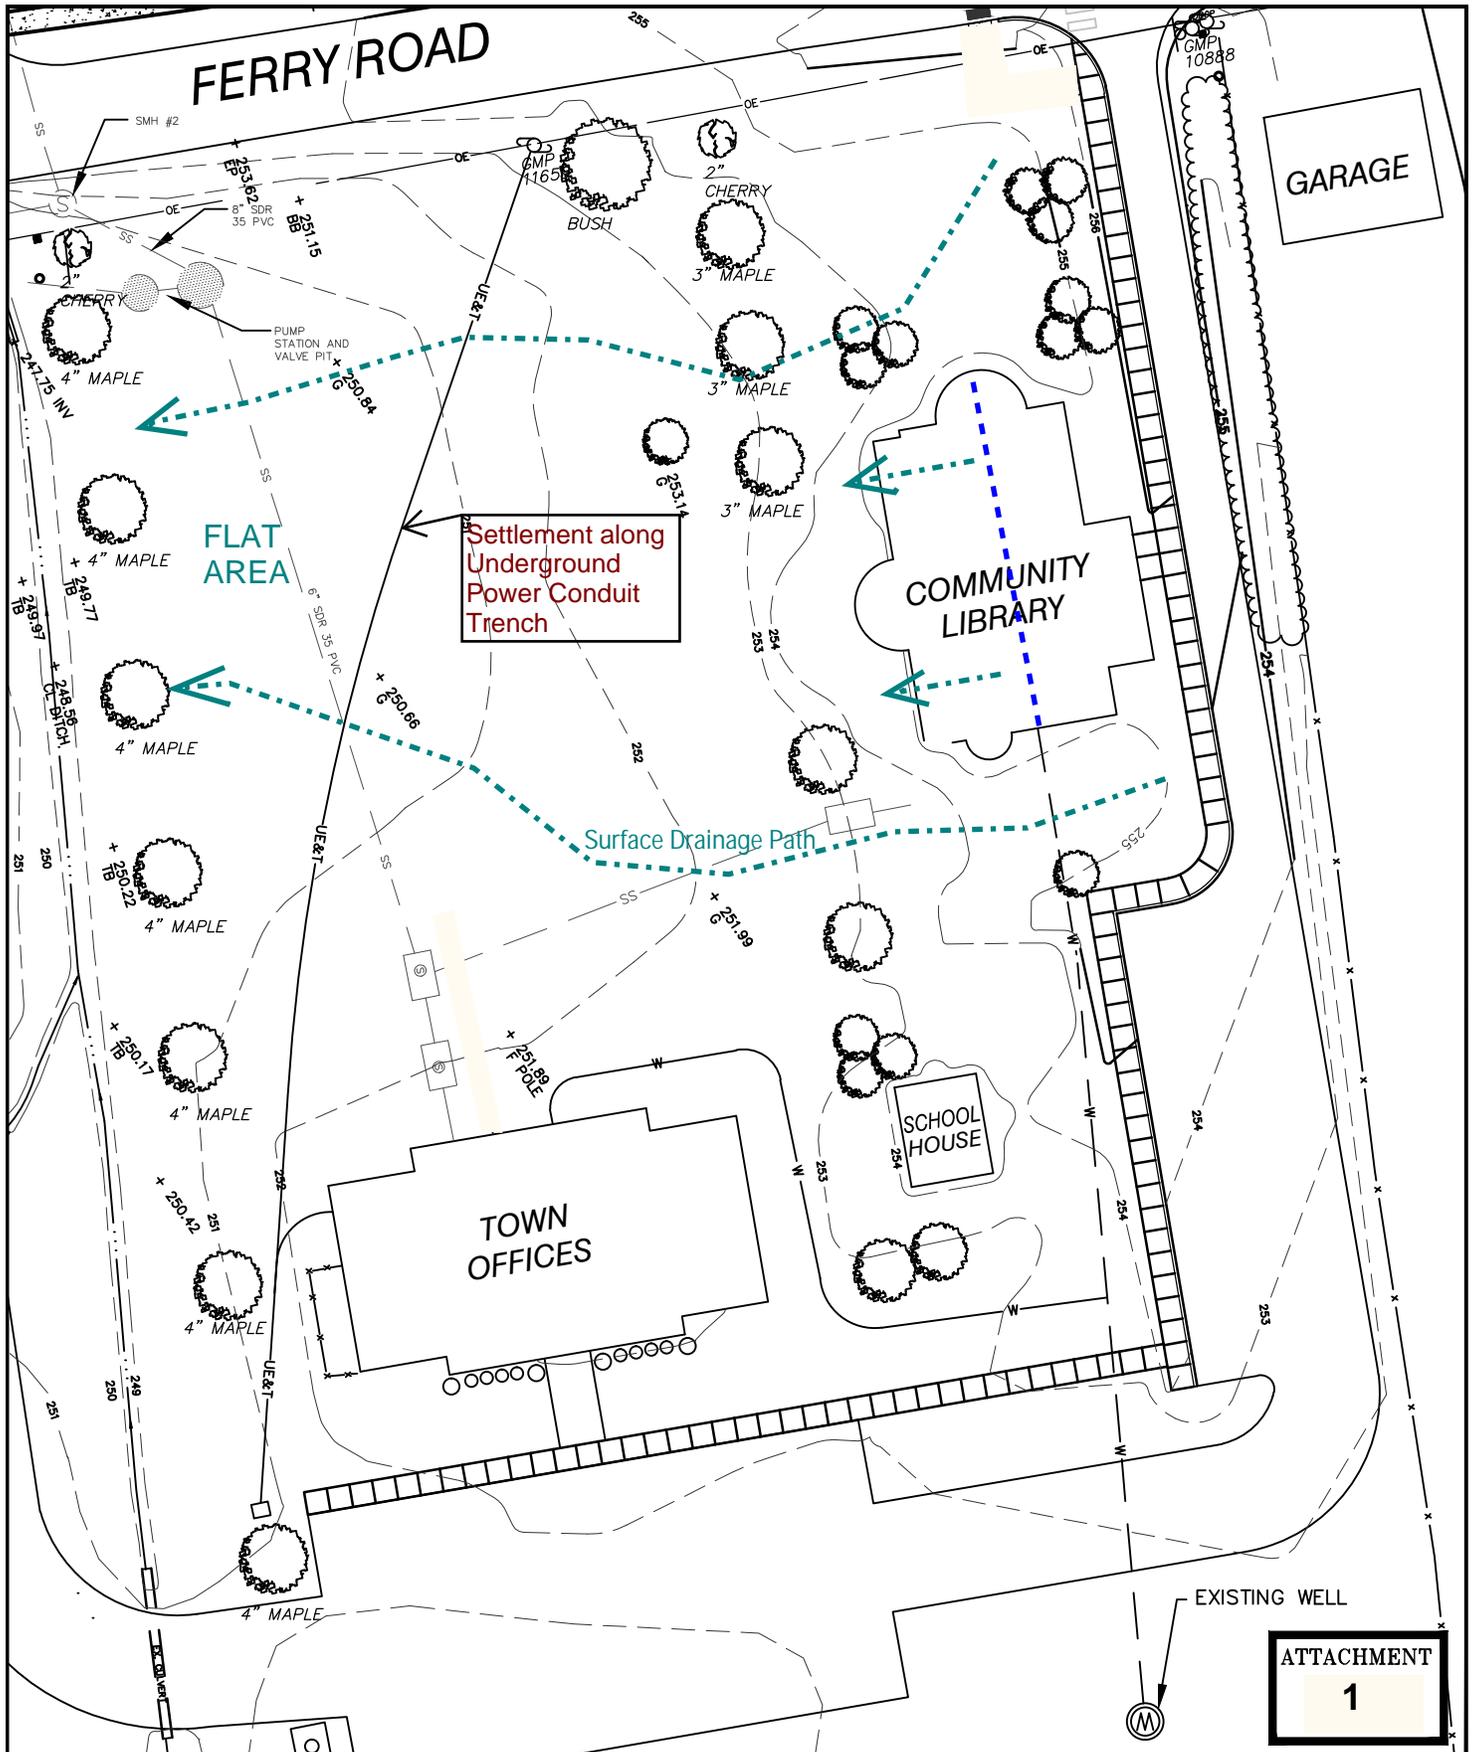
ATTACHMENT
1

The enclosed existing condition plan (Attachment 1) shows the existing lawn area surrounded by the Town Hall, the access drive shared with the Post Office, Ferry Road and the Library. The mapping shows the following features:

- The topographic contours show that the Library sits up above the lawn area. Surface drainage flows from the library lawn and roof top westerly toward the lawn area.
- Underground power and communications conduit runs from Ferry Road utility pole to the transformer on the west side of the Town Hall building. Our site

- The west side of the lawn is fairly flat
- The lawn area off of the northeast corner of the Town Hall building is poorly drained due to a lack of available pitch to direct surface water from the area.

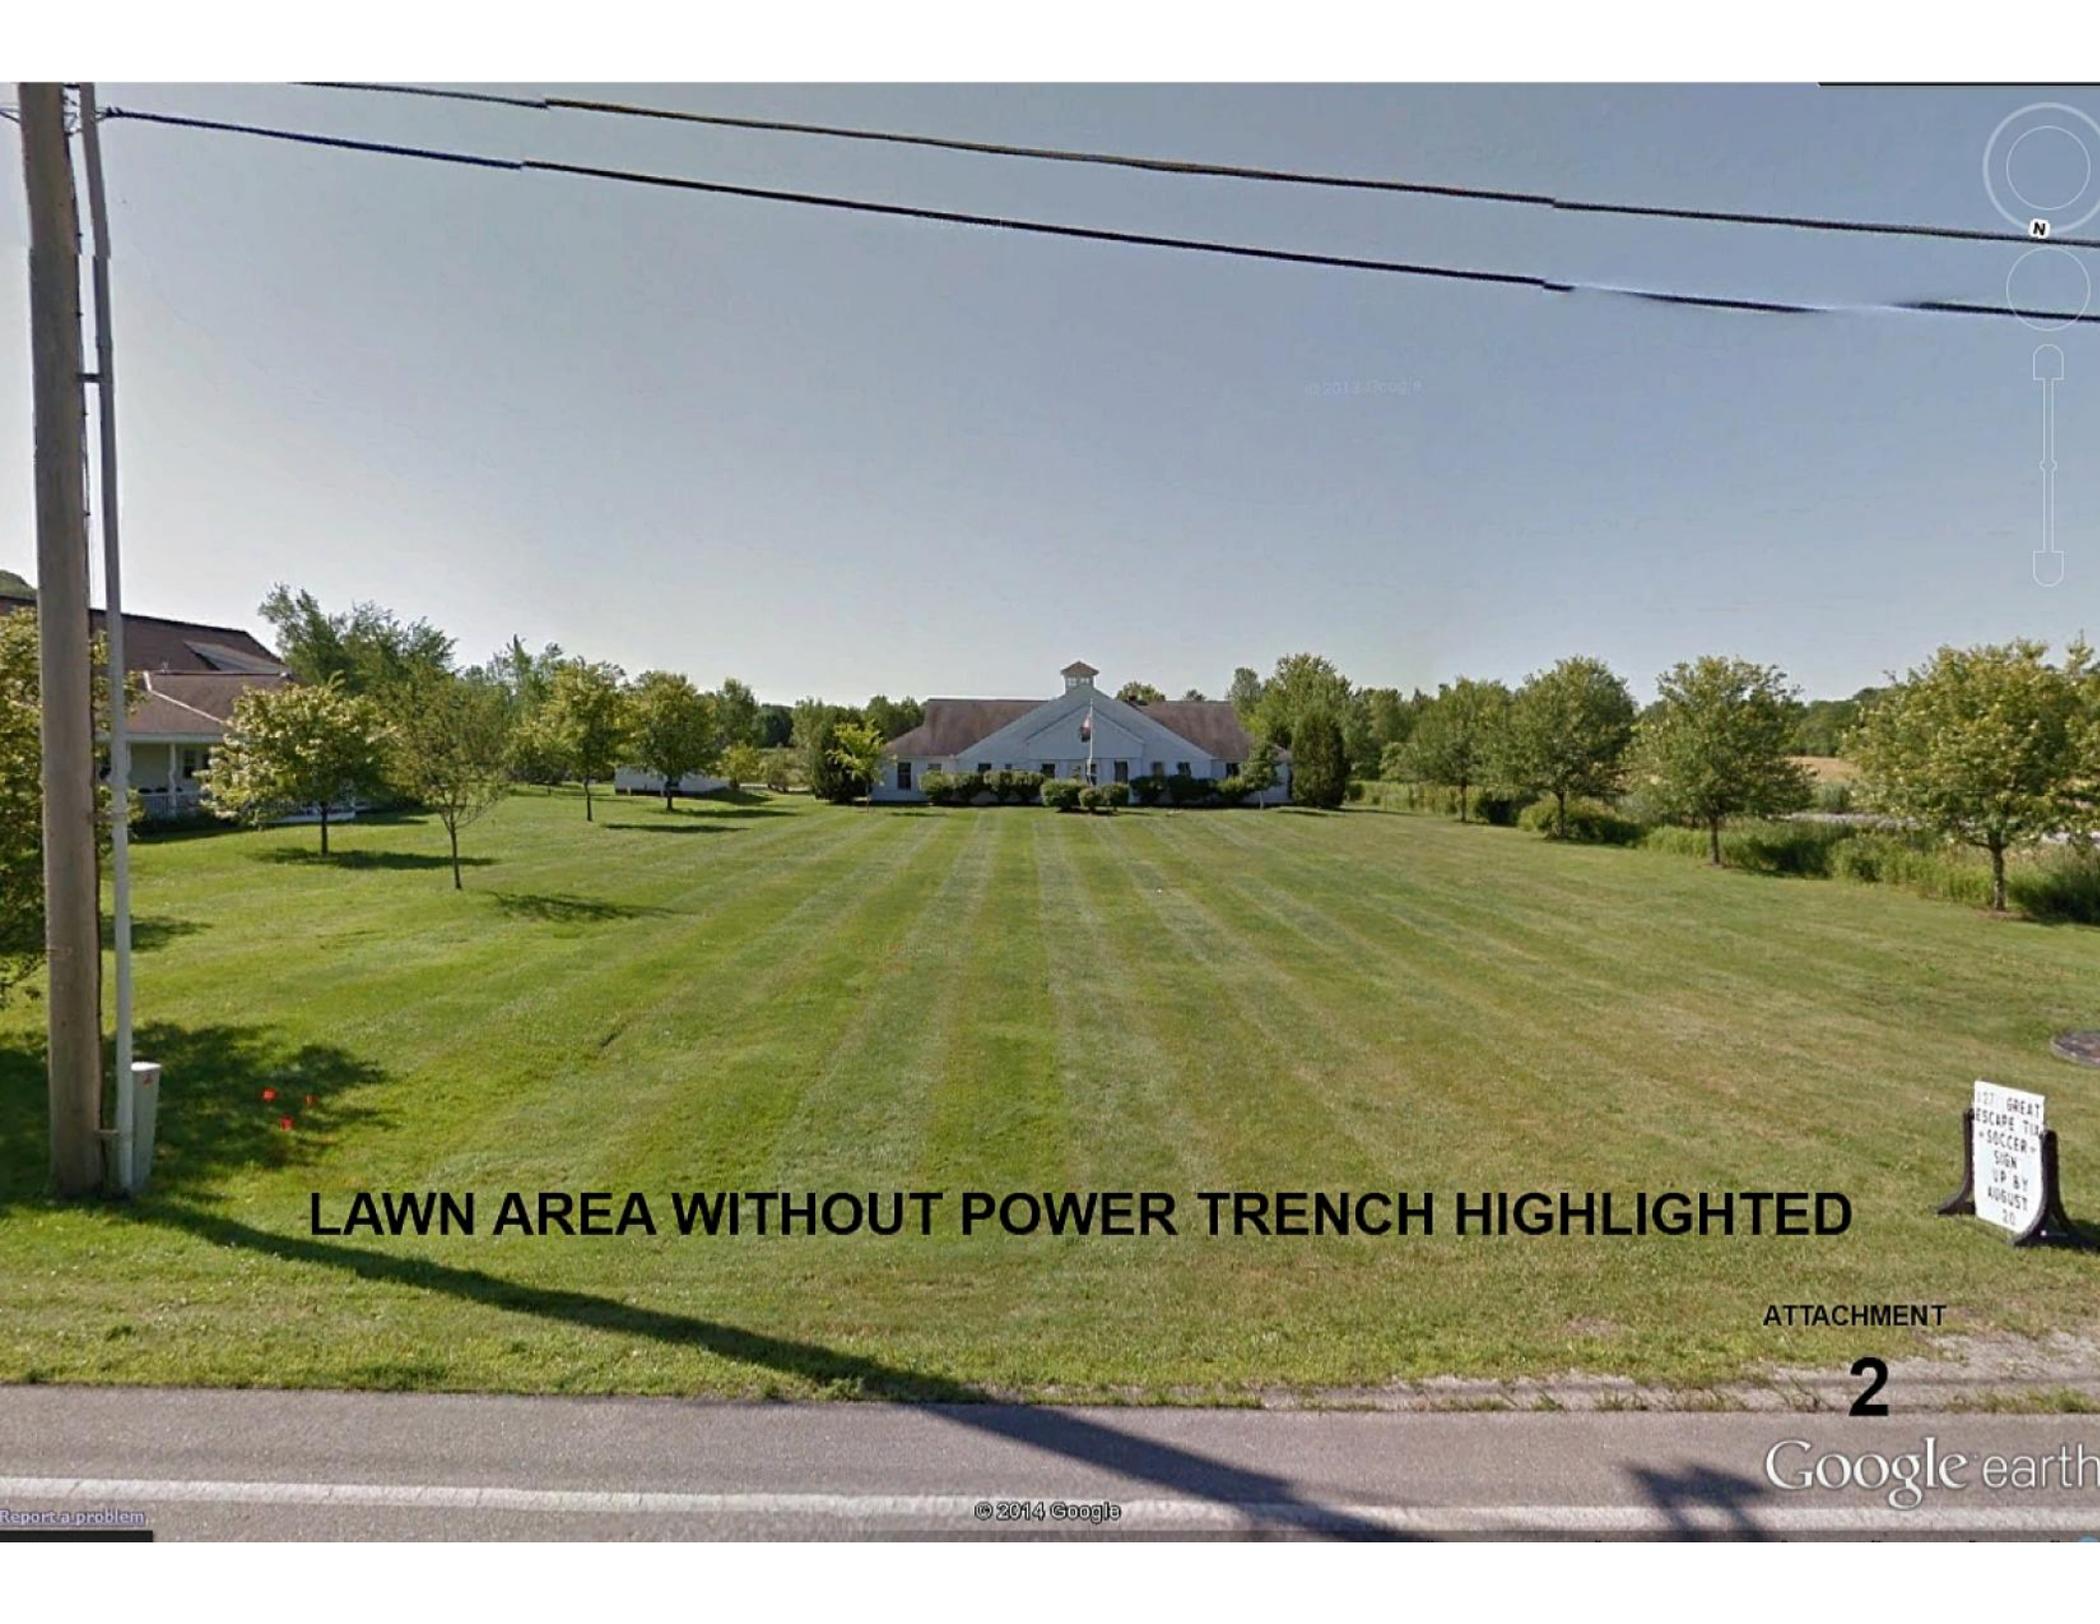
ATTACHMENT

review showed that settlement had occurred in a number of places along this route causing localized ponding further evidenced by the presence of distressed vegetation (See Attachments 2 and 3)

LAWN AREA WITHOUT POWER TRENCH HIGHLIGHTED

- Surface Correction – The localized ponding associated with the settlement of the subsurface power conduit installation should be eliminated through the placement of screened topsoil in a manner that re-establishes the east to west drainage pattern. There is a 50/50 chance that the growing conditions would be suitable to establish a sturdy stand of grass prior to the Town Party in early July. If this work is executed this Spring, it is still likely that some of these areas will need to be repaired following the event.

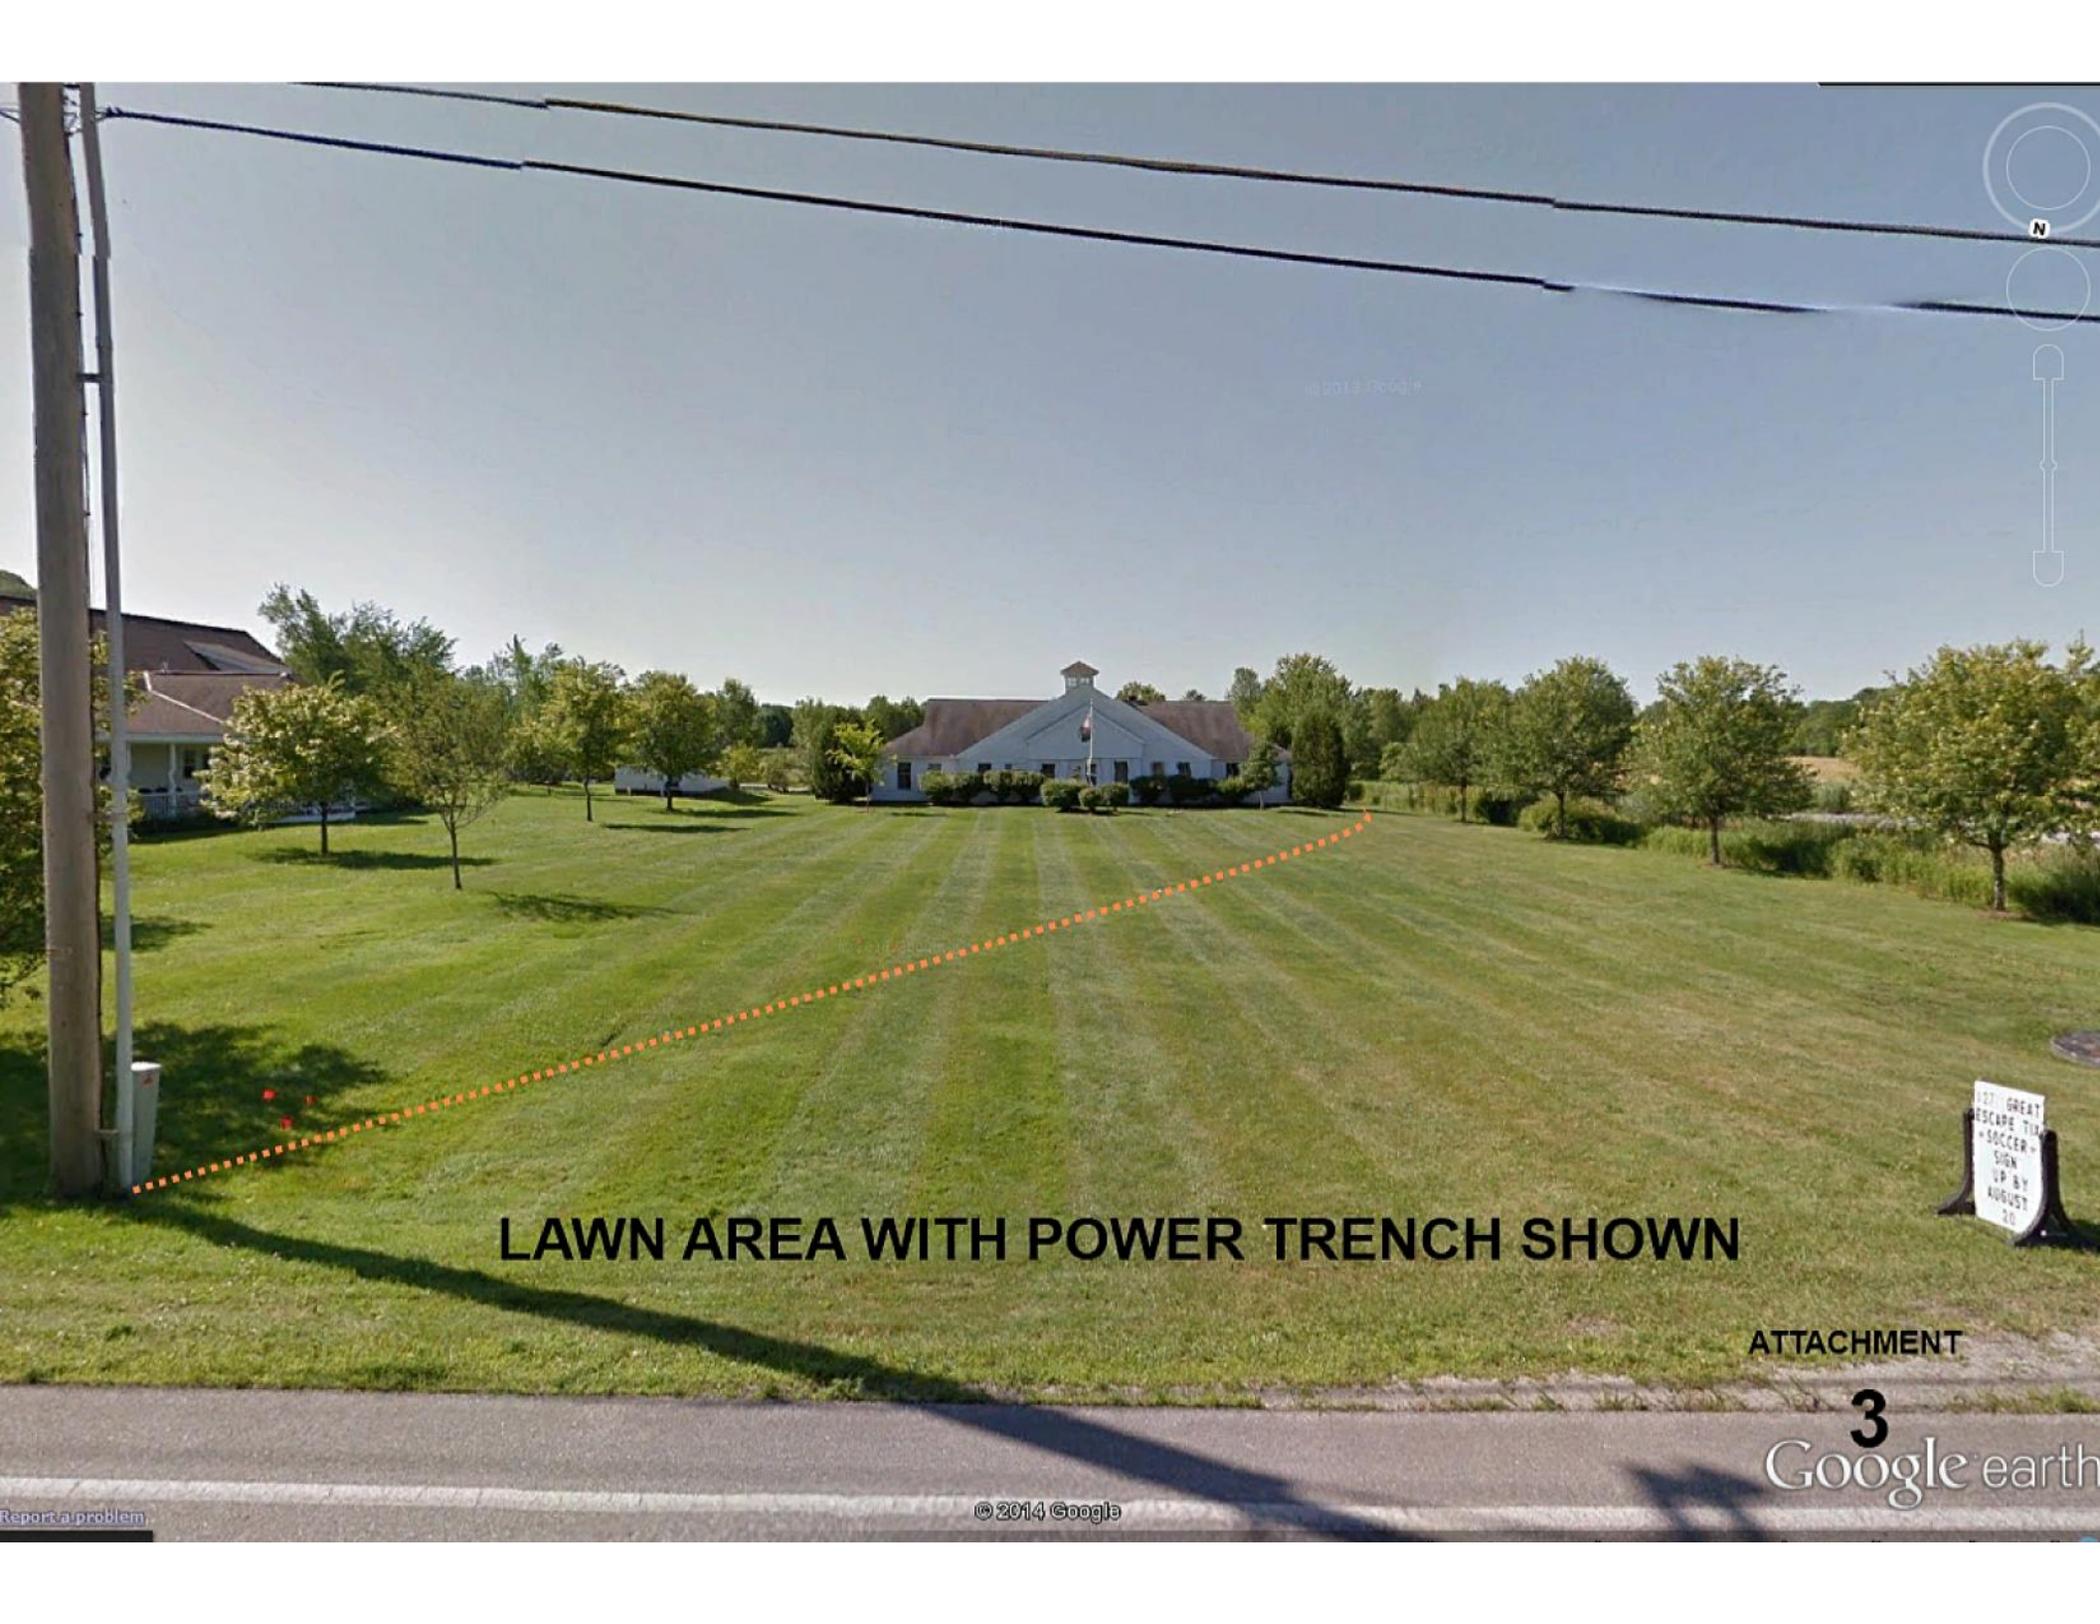
ATTACHMENT

LAWN AREA WITH POWER TRENCH SHOWN

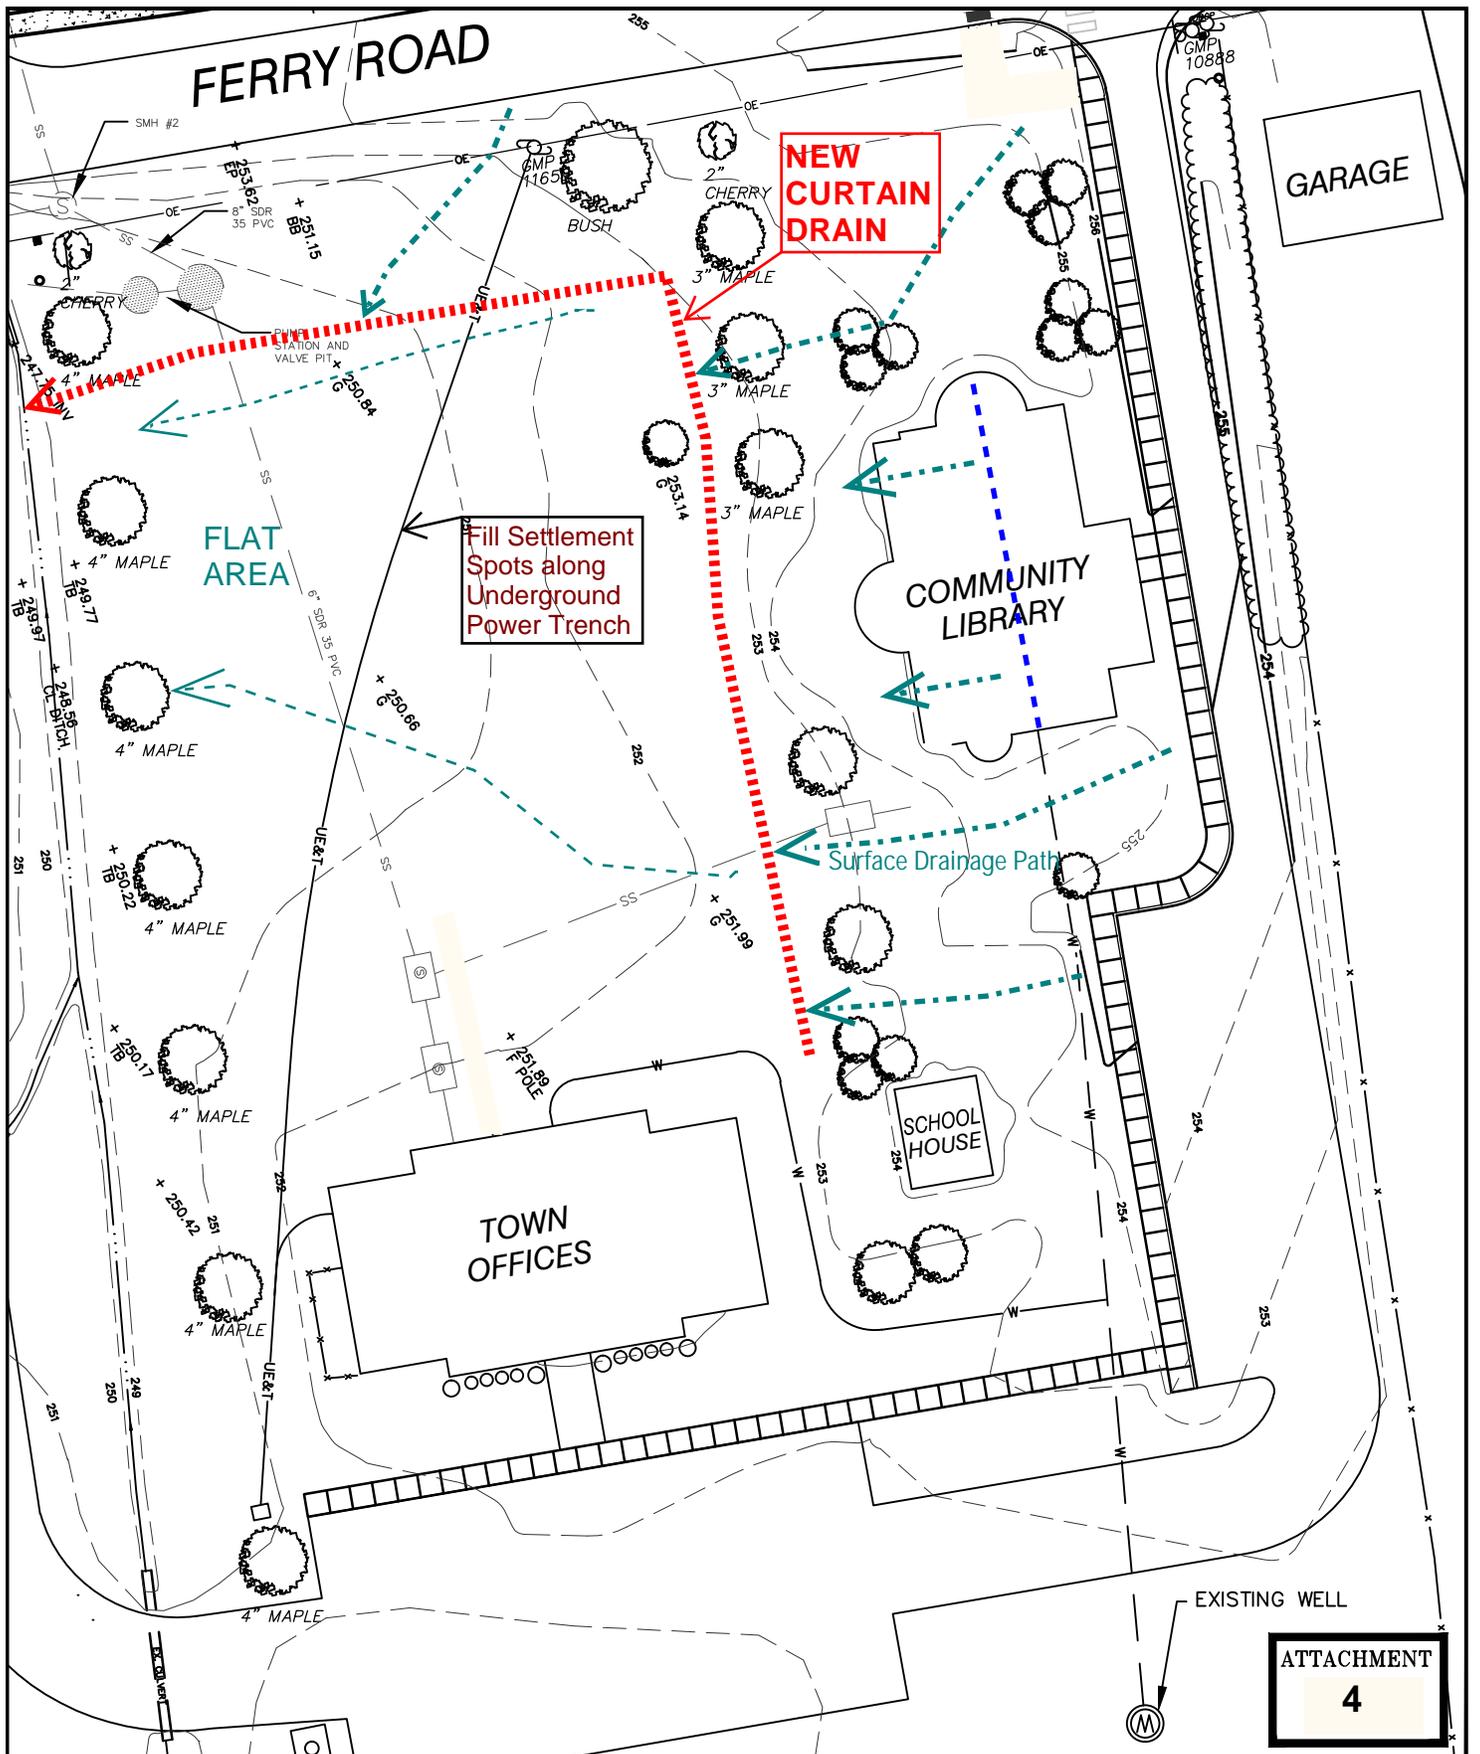
ATTACHMENT
4

- Surface Protection – The main lawn area receives runoff from Ferry Road and the Library. To minimize the amount of water getting to the lawn event surface, we would typically recommend that the use of grass lined swales to intercept and direct the surface water to a low point on the property away from the activity area.

As the existing lawn area is fairly flat in the north-south direction, we are recommending the use of a curtain drain (See Attachment 4).
