# Ahead of the Storm

## Existing Conditions Site Summary

### Mack Farm

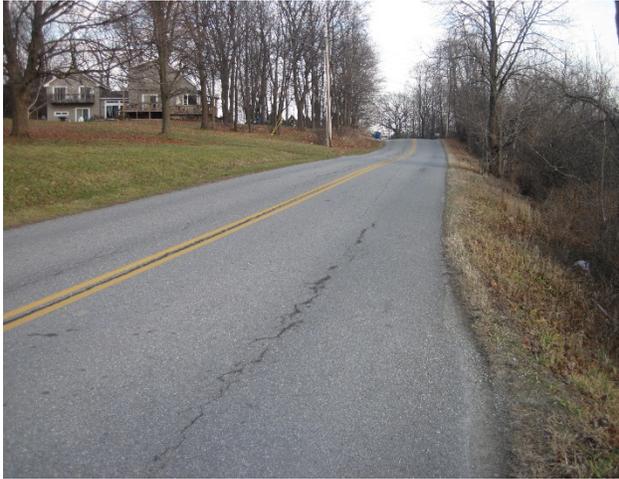
The swale along the north side of East Thompson Point Road at the Mack Farm field collects runoff from 17.3 acres including portions of East Thompson Point and Greenbush Roads, residential properties, and portions of two farms (Figure 1). Stormwater runoff has occasionally spilled out of the swales and caused erosion in the adjacent farm field. This project will improve water quality and flood resiliency.

*Figure 1: Runoff from Greenbush Road and homes on the far side of the road travels through the adjacent farm fields to Mack's farm field.*

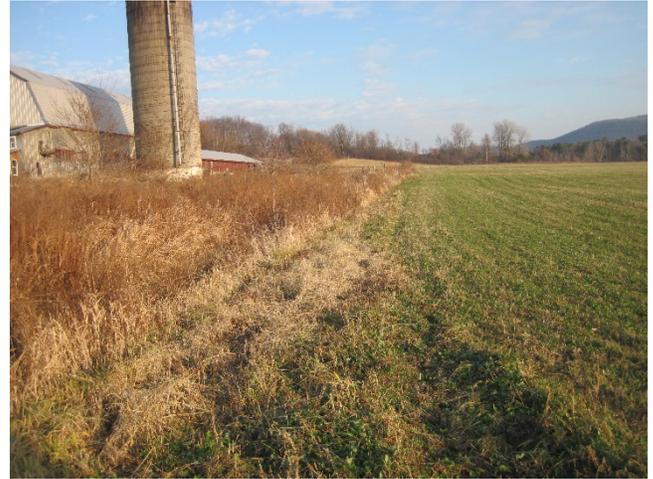
*Figure 3: A swale runs from north to south along the west edge of the Mack's farm field, carrying water to the East Thompson Point Road swale.*

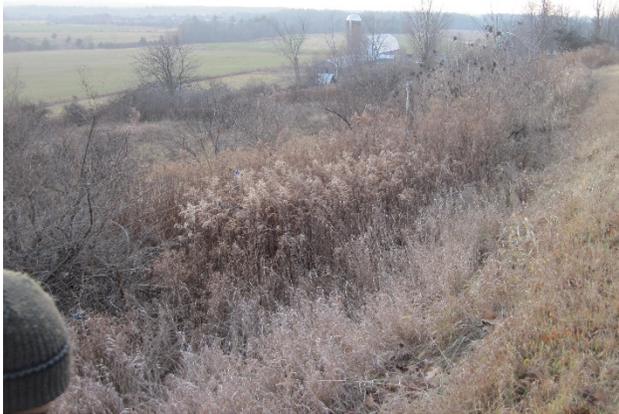
*Figure 2: Runoff from fields and Greenbush Road travel through farm fields down to the site.*

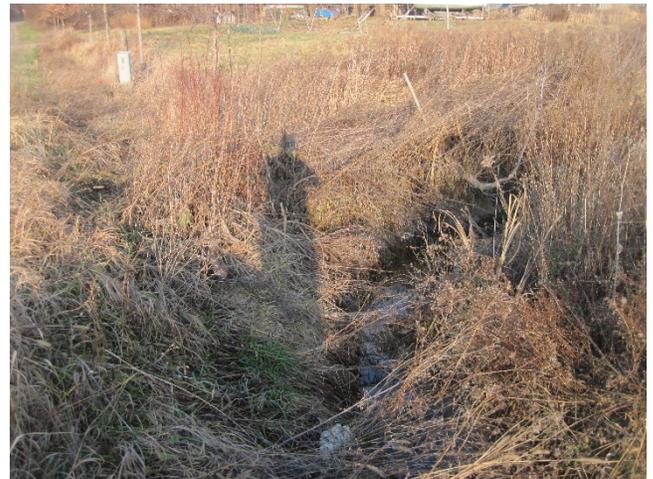
*Figure 4: The swale from the north turns sharply to the east, joining the East Thompson Point Road swale.*

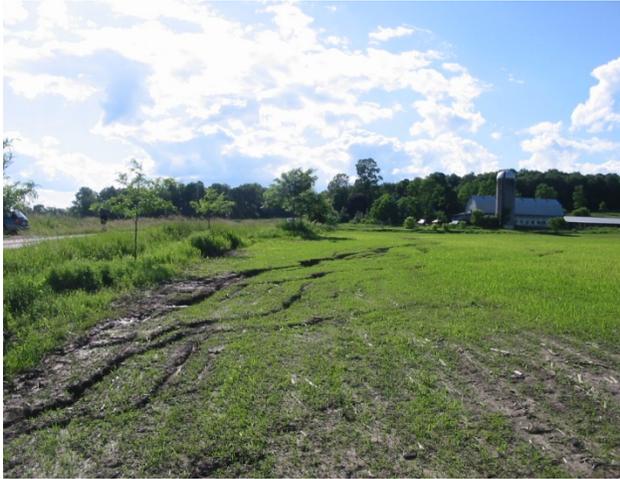
The swales around the field are not adequate to carry runoff all of the time, especially when they are filled with snow and ice, causing runoff to exit the swales and travel across the farm fields leading to erosion. The swale size was previously constrained by both town-owned trees in the ROW that have now been moved, and the agricultural use of the field. Both swales are partially vegetated with grass and have some exposed soils.

*Figure 5: Rill erosion has occurred in the Mack farm field when water in the swale traveling from the north leaves the swale and cuts across the field to the road swale.*

1. Improve swales around the field to increase capacity, slow velocity, create inline storage, and provide sediment retention.
2. Create a naturally vegetated buffer between the active farm field and the edge of the road swale.
3. Discuss snow storage with the Town Road Foreman to reduce ice and snow clogging of road swale.
4. Create a bioretention area at the end of the road swale prior to water entering Thorp Brook.
5. Manage agricultural use of field to reduce concentration of flow at field edges.
6. Adjust farm practices to reduce rutting of field.

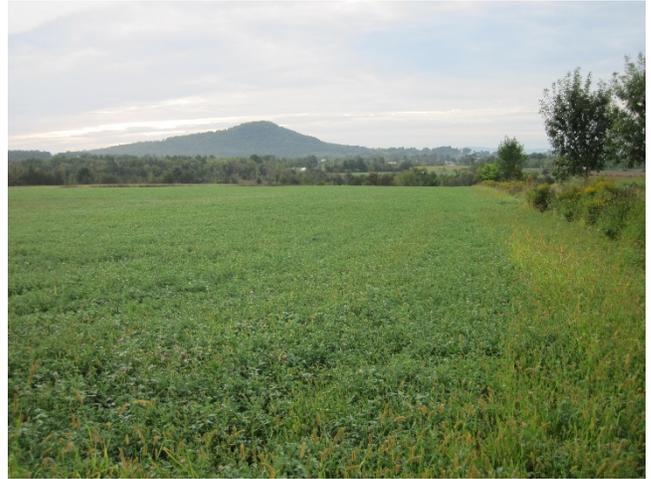
The agricultural use of the field is currently to the edge of the swale. The field has been planted with a cover crop that is to remain for a minimum of 5 years.

*Figure 7: The Mack farm field is harvested close to the edge of the swale. The trees in this photo have been moved.*

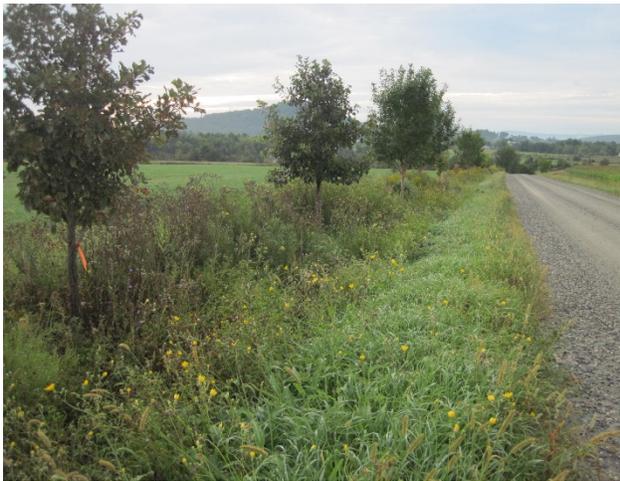
The road swale is crossed by a field access where water flows through a 12-inch corrugated metal pipe. The swale has a slope of 1.8% to the west of the field access and between 4.3 and 5.5 % to the east of the field access.

*Figure 6: A vegetated swale travels along East Thompson Point Road. The trees in this photo have been moved.*
