Champlain Valley Co-Housing Trail

Sitework Photopages

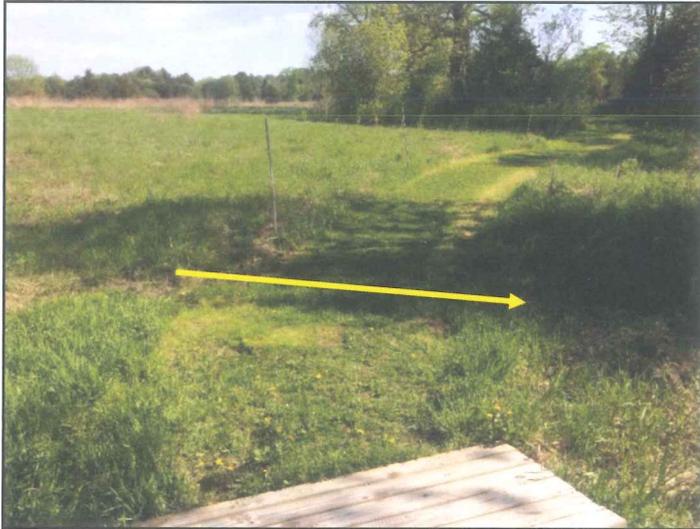
Photo Number: 1

The field to the left of the trail is draining water towards the boardwalk and gullying across the alignment. By installing a culvert, the water will be able to flow below the trail and not erode the surfacing.

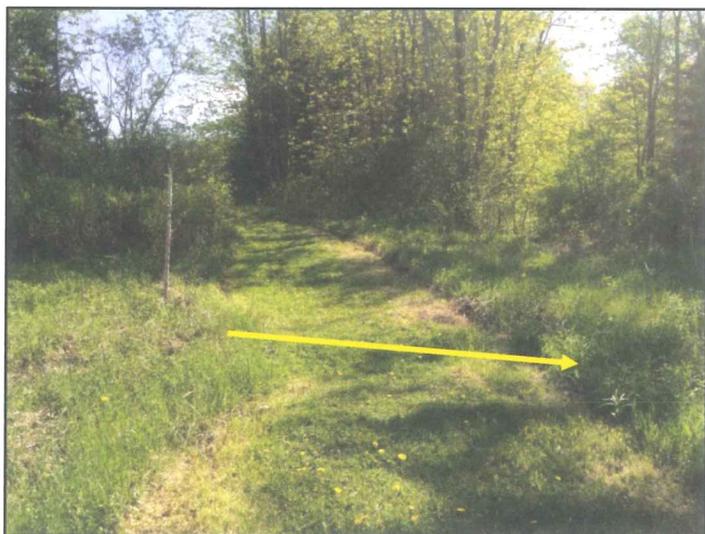
Photo Number: 2

To ensure proper drainage under the trail by water flowing off the farm field, large cobbles can be aligned to function as a culvert would. The tread should be elevated with crushed stone and wrapped in Geotextile Fabric.

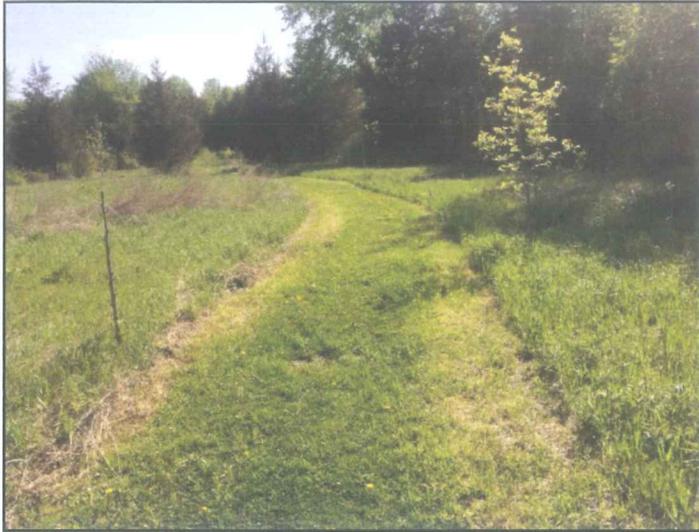
Photo Number: 3

This section needs to be elevated with crushed stone to maintain water drainage beneath the trail tread. Geotextile Fabric will work to separate the surfacing from the crushed stone.

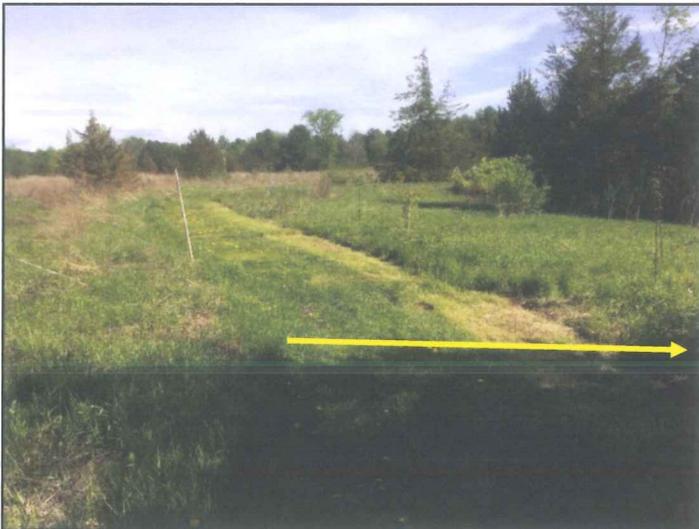
Photo Number: 4

Water is gullying and causing erosion as it travels from left to right across the trail. A culvert needs to be installed to ensure proper drainage.

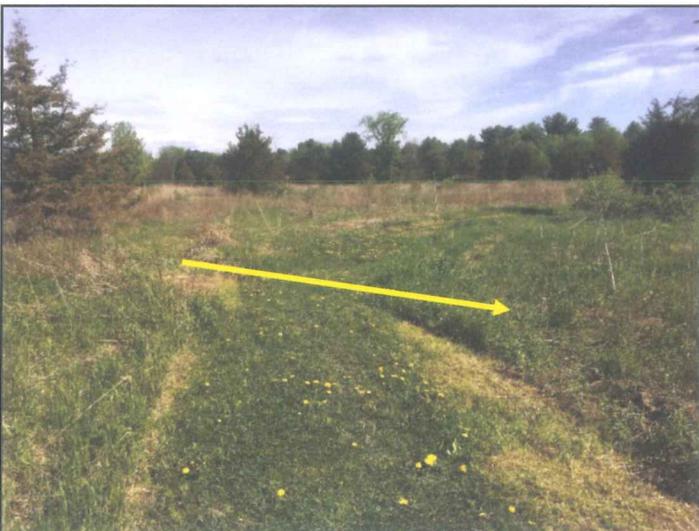
Photo Number: 5

The water is funneled into this small gully and is traveling from left to right across the trail tread. A culvert should be installed to ensure proper drainage. As with all prescribed culverts, this culvert should have rip rap installed at either end to prevent channeling of the water as it enters or is discharged.

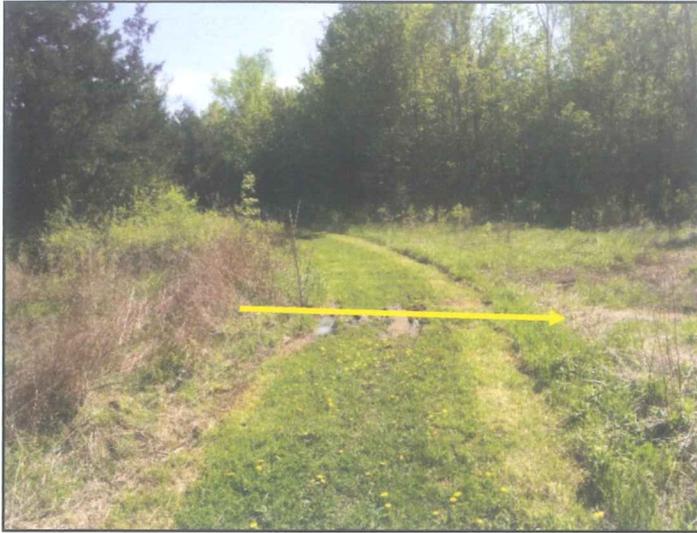
Photo Number: 6

The water is funneled into this small gully and is traveling from left to right across the trail tread. A culvert should be installed to ensure proper drainage. As with all prescribed culverts, this culvert should have rip rap installed at either end to prevent channeling of the water as it enters or is discharged.

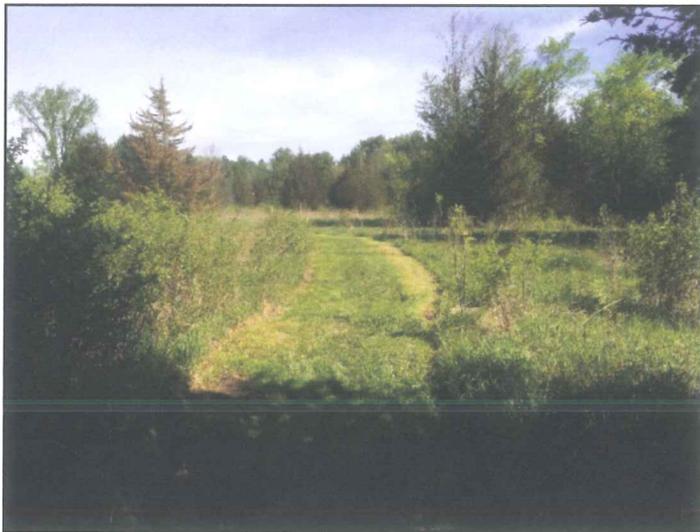
Photo Number: 7

This section of trail requires the installation of crushed stone below the trail tread to ensure that the tread is elevated out of standing water.

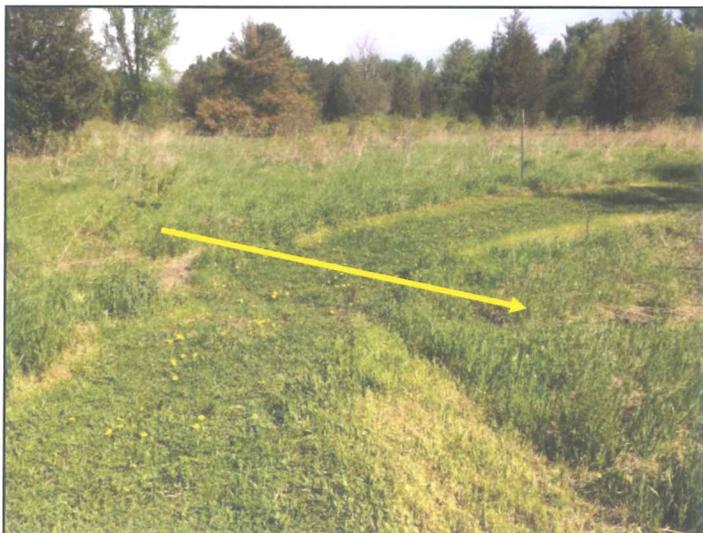
Photo Number: 8

The water is funneled into this small gully and is traveling from left to right across the trail tread. A culvert should be installed to ensure proper drainage. As with all prescribed culverts, this culvert should have rip rap installed at either end to prevent channeling of the water as it enters or is discharged.

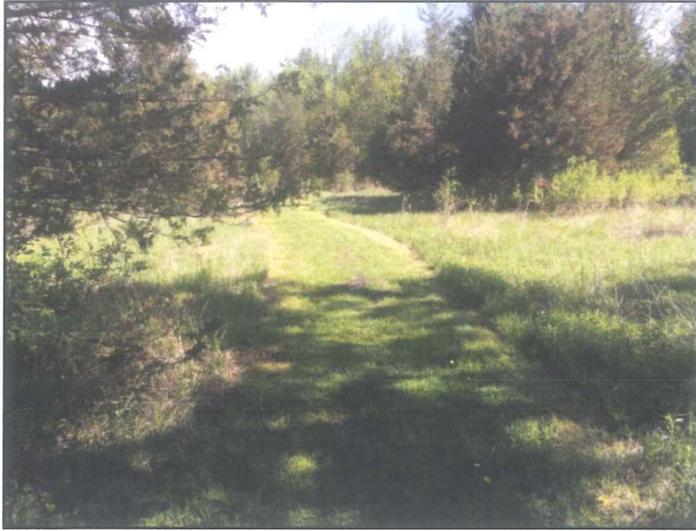
Photo Number: 9

This long flat section has evidence of standing water and seepage across the trail. A Drainage Lense should be installed to allow water to flow beneath the tread as needed during high flow times of the year.

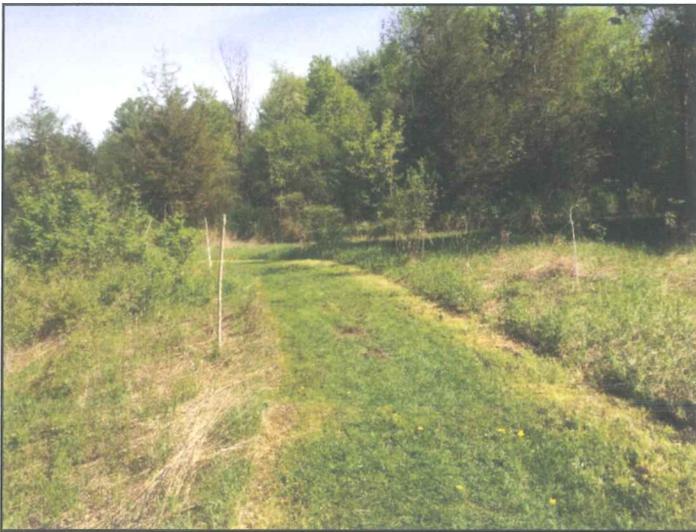
Photo Number: 10

This long flat section has evidence of standing water and seepage across the trail. A Drainage Lense should be installed to allow water to flow beneath the tread as needed during high flow times of the year.

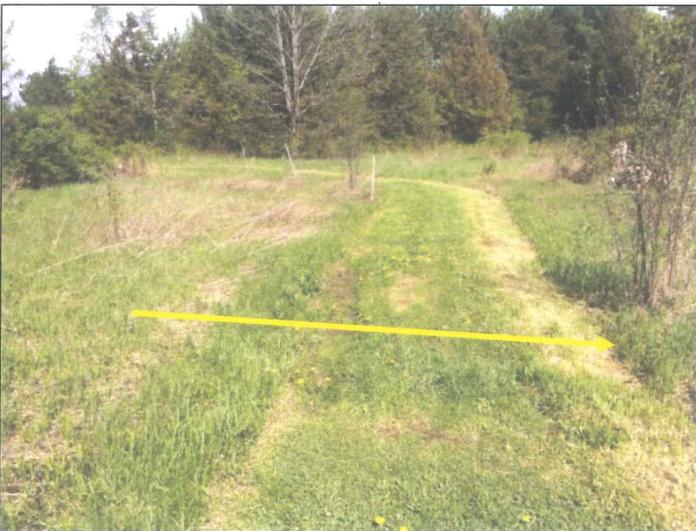
Photo Number: 11

To ensure proper drainage under the trail by water flowing off the farm field, large cobbles can be aligned to function as a culvert would. The tread should be elevated with crushed stone and wrapped in Geotextile Fabric.

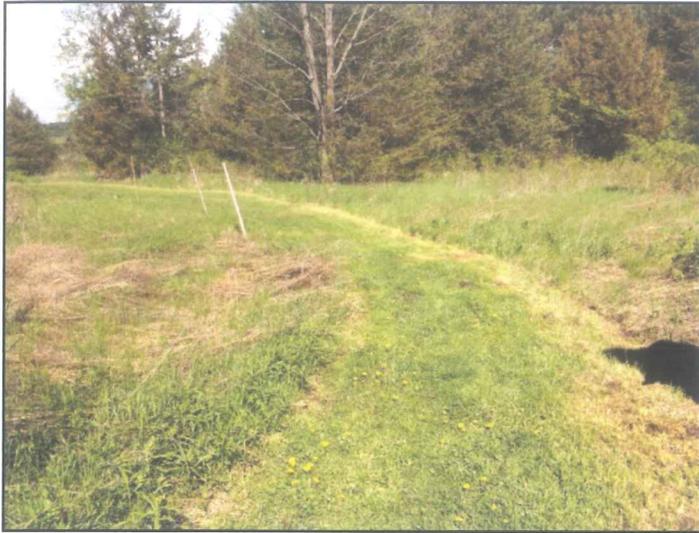
Photo Number: 12

As this section continues, it will require crush to be installed below the trail tread. This will help ensure proper drainage of water from the surrounding topography.

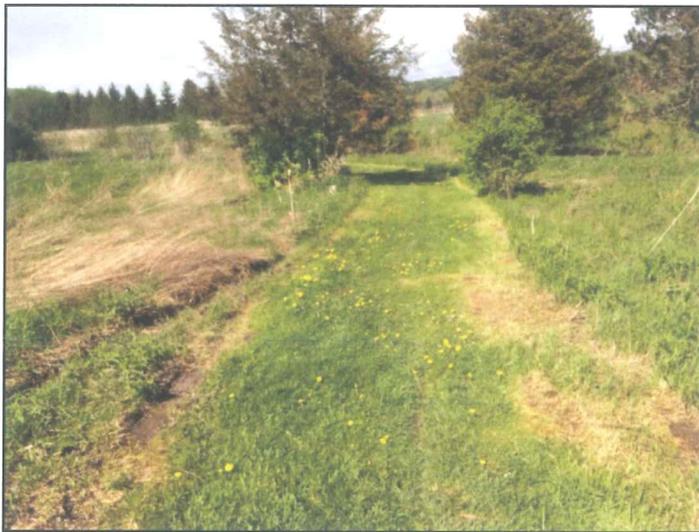
Photo Number: 13

This stretch of trail will require elevated tread with 2-4" cobble wrapped in Geotextile Fabric. By elevating the trail tread, water is able to drain below the surface through the cobble stone.

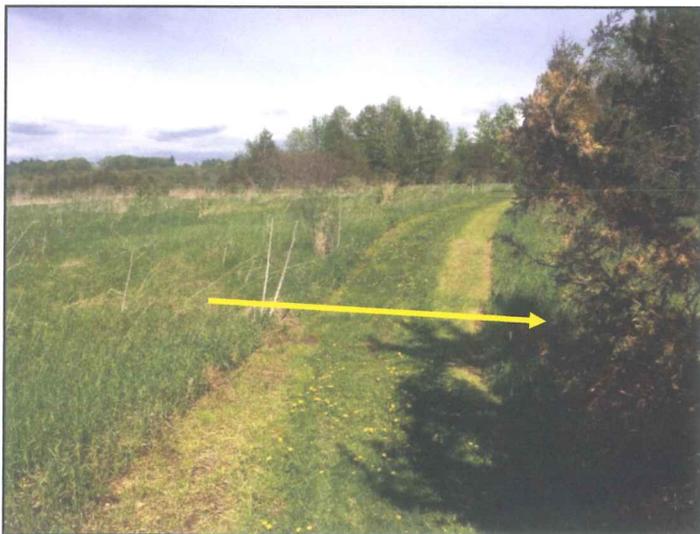
Photo Number: 14

This section of trail receives water drainage from the field on the left. By installing a culvert, the trail will not endure periodic heavy

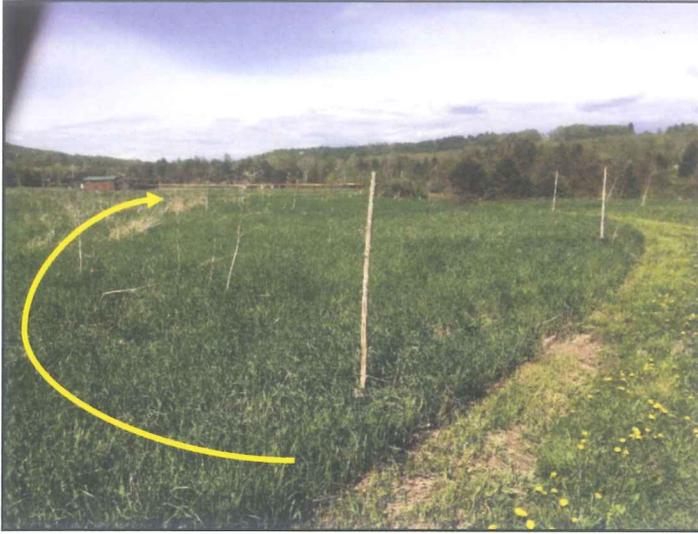
Photo Number: 15

As the current trail alignment joins the access trail to the Berry Farm, there is an abrupt drop of 15-20%. This is unsustainable. By curving the trail to the left, it is possible to maintain gentle grades while making a safe connection to the access trail.

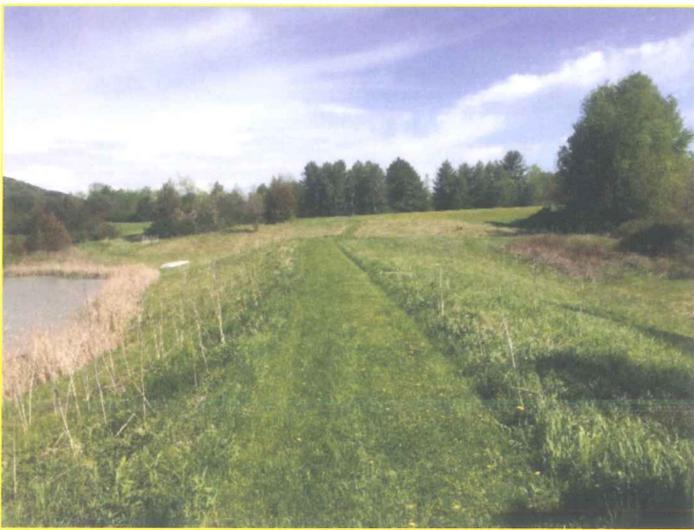
Photo Number: 16

While crossing this earthen dam, it will be critical to maintain an appropriate crown for drainage.

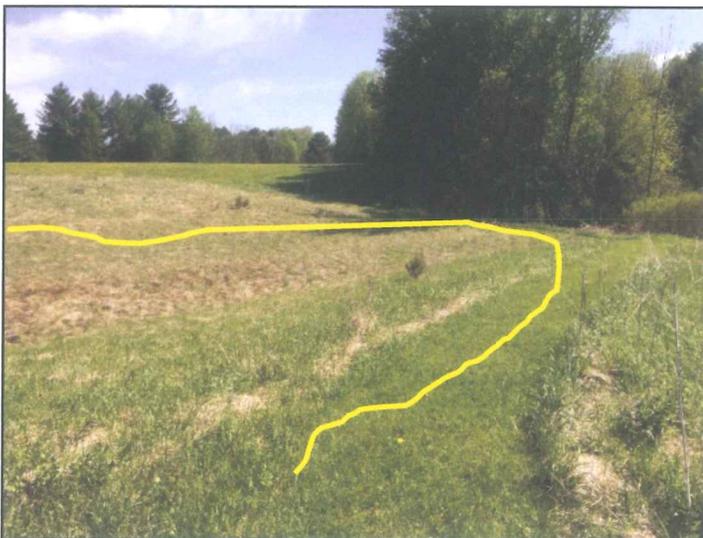
Photo Number: 17

The current trail alignment brings the trail directly down the hillside with grades 12-15%. This will not be sustainable for a naturally surfaced trail. By incorporating this broad turn and making full use of an existing trail path, the trail can be relocated to have a running grade of 5-8%.

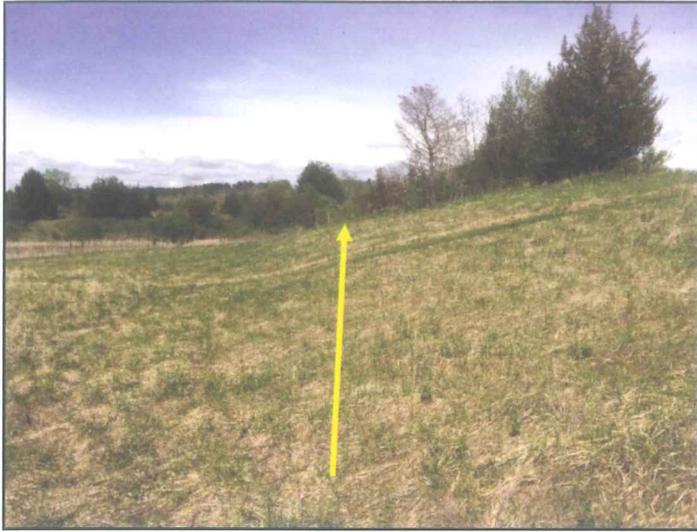
Photo Number: 18

Once past the broad turn, the trail should be located across the gentle cross slope of this hillside. The trail will enable the drainage to sheetflow across the trail which will eliminate channeling. Also, the running grade will be maintained at 5-8%.

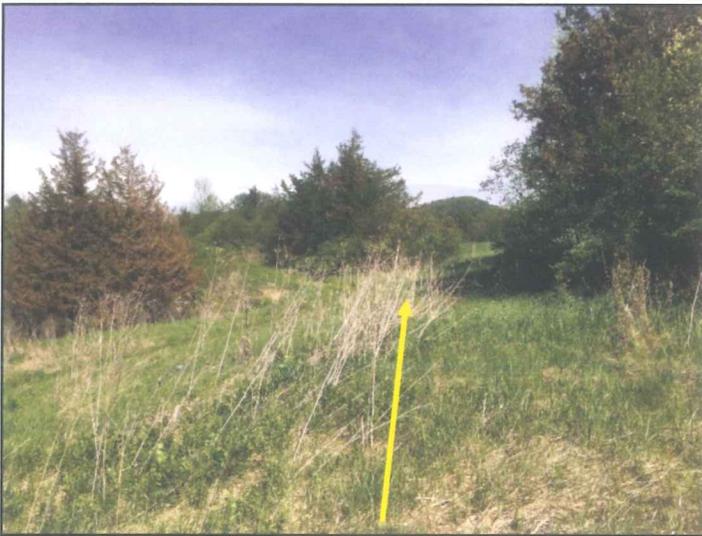
Photo Number: 19

This will be the alignment of the final section of trail reroute. The trail will reconnect with the existing alignment and head towards the terminus.

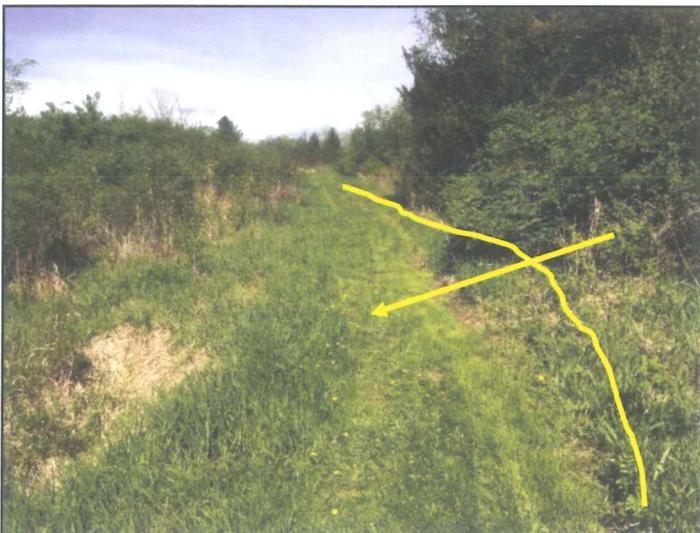
Photo Number: 20

There is a large gully on the lefthand side of the trail. This could pose a safety issue as well as a drainage issue. The trail should be moved uphill to make the most use of the crosslope. Water is also draining from right to left. A culvert should be installed to manage the water under the trail towards the gully.

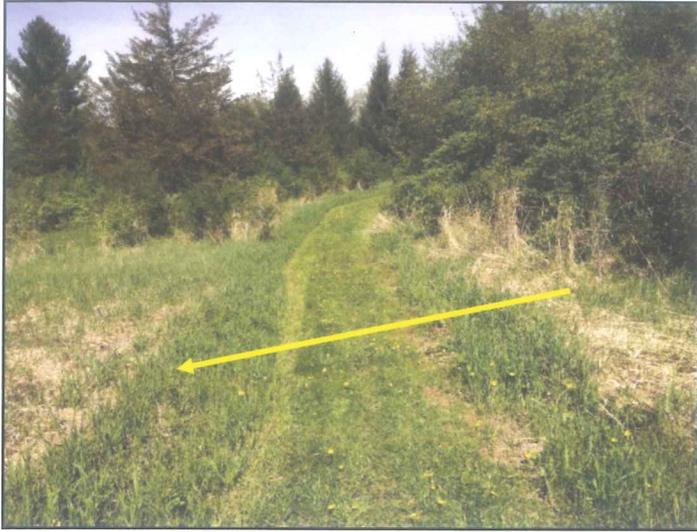
Photo Number: 21

This section of trail will require uphill ditching and to capture water draining from right to left. The water should be directed towards a drainage structure lined with large cobble stone and covered with Geotextile Fabric.
