AHEAD OF THE STORM

Site: Charlotte Park and Wildlife Refuge

Location: U.S. Route 7 and Greenbush Road, Charlotte, Vermont

Existing Conditions Site Summary

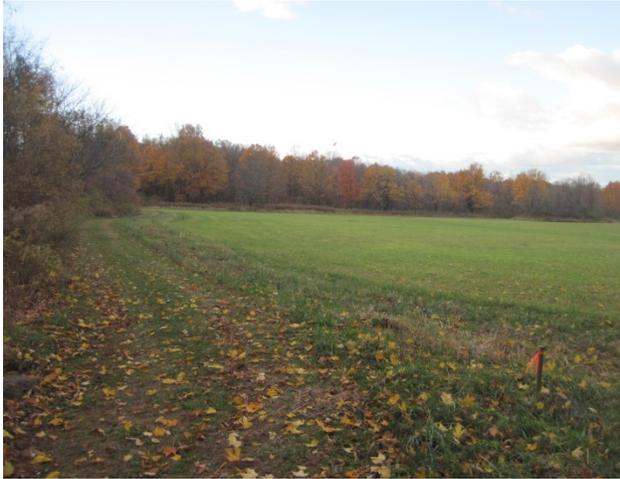
Figure 1: Looking south along the roadway at the east end of the field, two culverts concentrate water (at stakes).

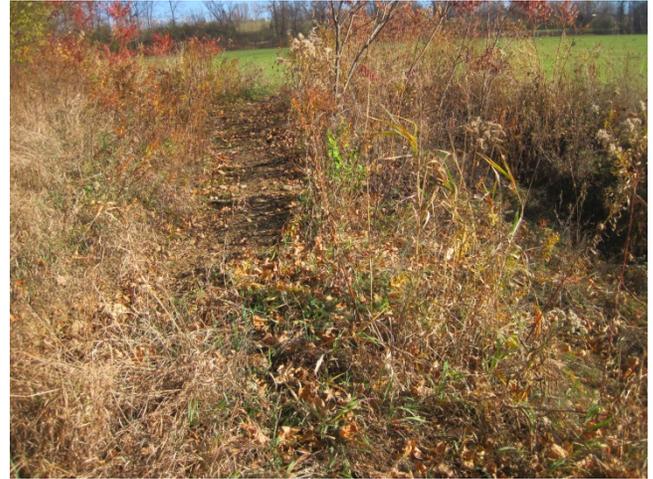
Figure 4: Looking east along a horsepath leading into the field from adjacent property.

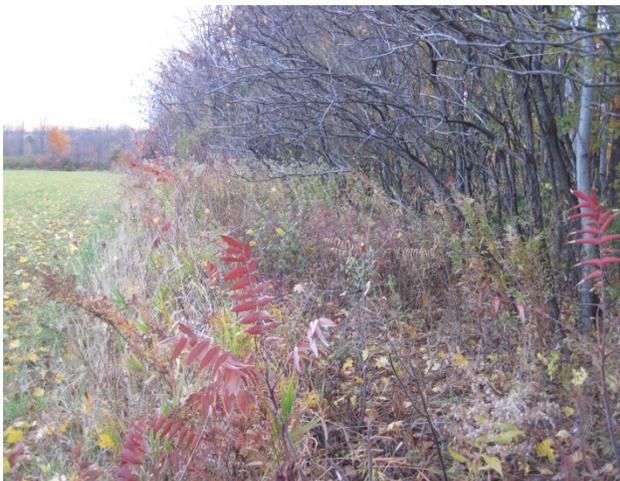
Small sections of rill erosion exist off of the edge of the field in the northern brushline that act as swales. These swales concentrate runoff for a short distance then lose definition allowing runoff to spread and flow into the wooded area to the north as sheet flow. The three sections of erosion are each approximately 70 feet long and vary in depth from 4 inches to 18 inches.

Figure 2: Looking west along the northern edge of the field along the brushline near the east end of field.

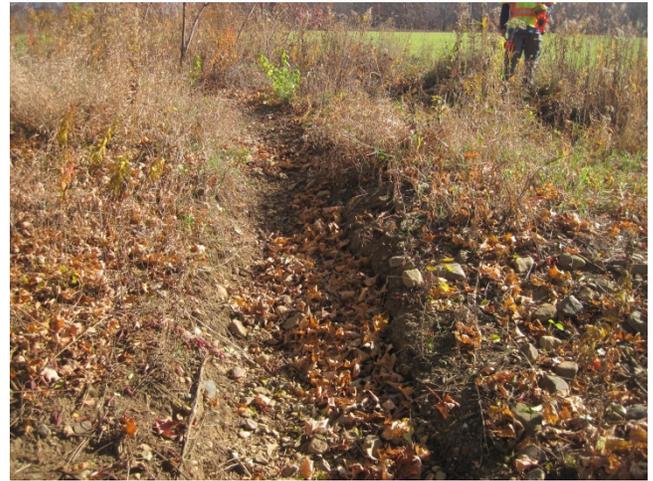
The most severe erosion area near the horsepath has a drainage area of 0.4 acres. The other two locations have varying drainage patterns based on current ruts in the field.

Figure 5: Erosion is actively occurring along the horsepath and in the adjacent swale (hidden in vegetation).

1. Continue to allow water leaving the culverts under Byington Road to flow overland in sheet flow.
2. Improve the horsepath entrance area with buried logs and check dams.
3. Improve rill erosion areas with check dams and increased vegetative buffer to prevent further gully formation.

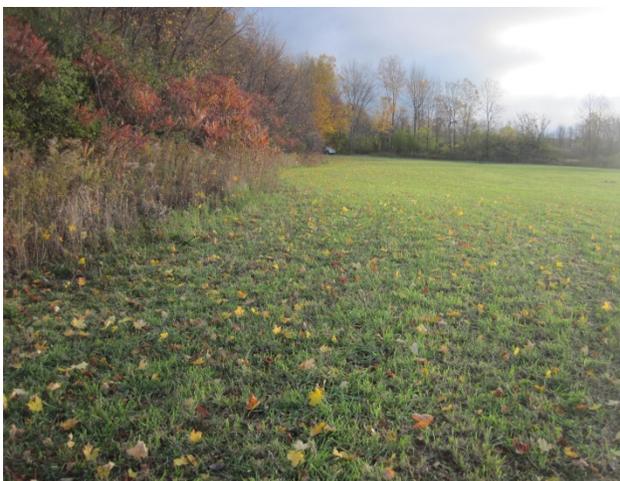
Figure 3: Looking east across the field along the north brushline.

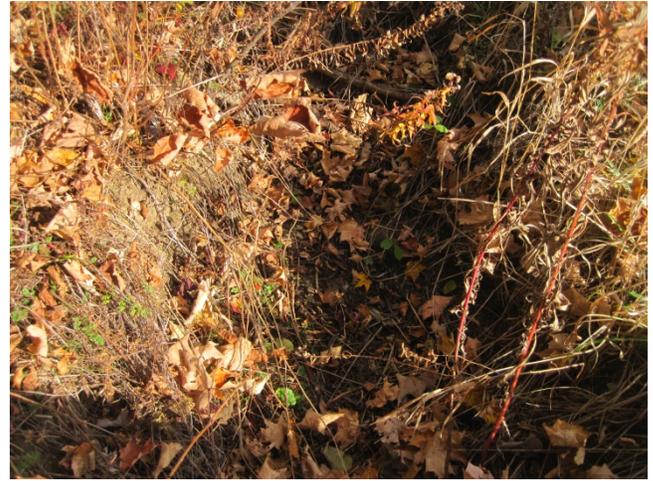
Figure 6: Active erosion in the swale adjacent to the horsepath, partially hidden by vegetation.

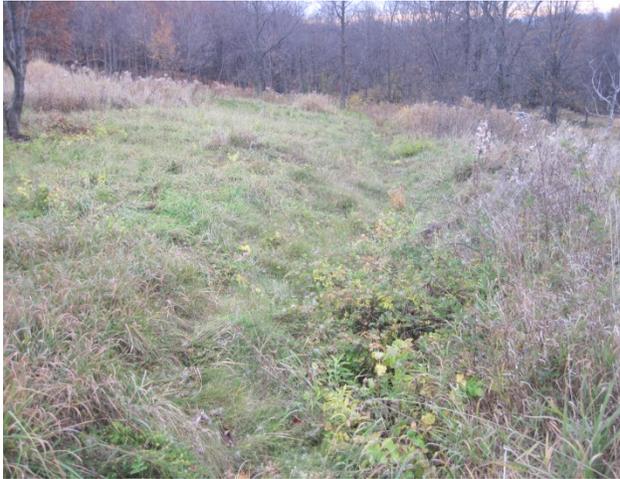
The cross-slope swale parallel to Byington Trail collects runoff from 2.1 acres and is now experiencing erosion. This swale drains to the southwest discharging to a headwater tributary of the Holmes Brook. Just before entering the Holmes Brook tributary, the runoff in the swale runs through a small historic farm junkyard of mostly metal.

Figure 7: Looking northeast along a cross-slope swale running parallel to the Byington Trail.

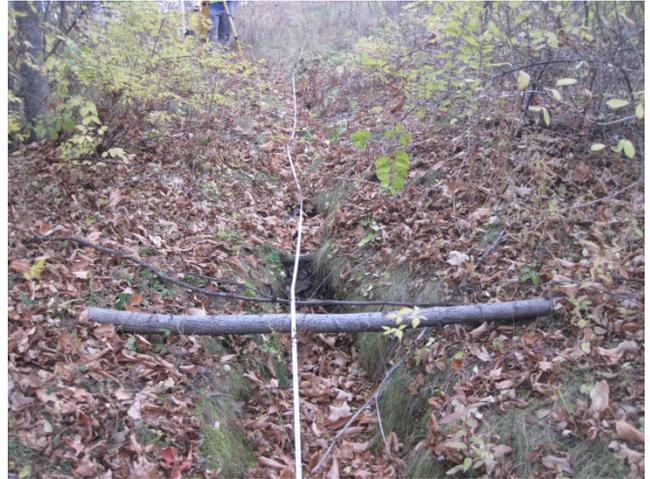
The downstream end of the cross-slope swale has eroded where an active headcut is forming. Active erosion in the swale is approximately 75 feet long, between 8 and 18 inches deep, and up to 1.5 feet wide.

Figure 10: Active gully erosion is occurring near where the cross-slope swale meets the stream.

1. Arrest gully erosion and headcutting before it worsens using applications of log structures and vegetation.

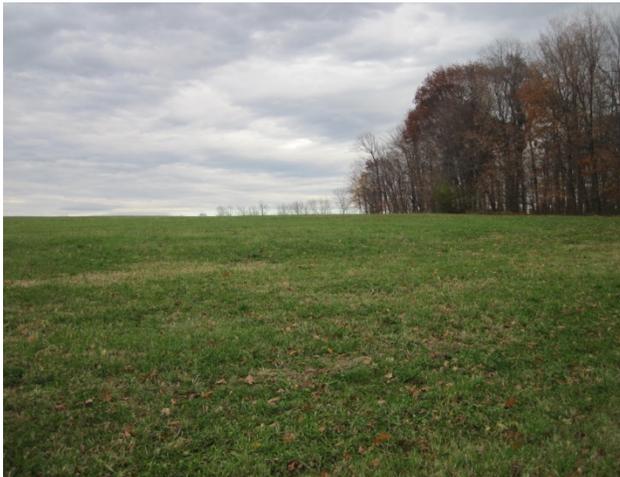
Figure 8: Looking east across the upper field that drains to the cross-slope swale.

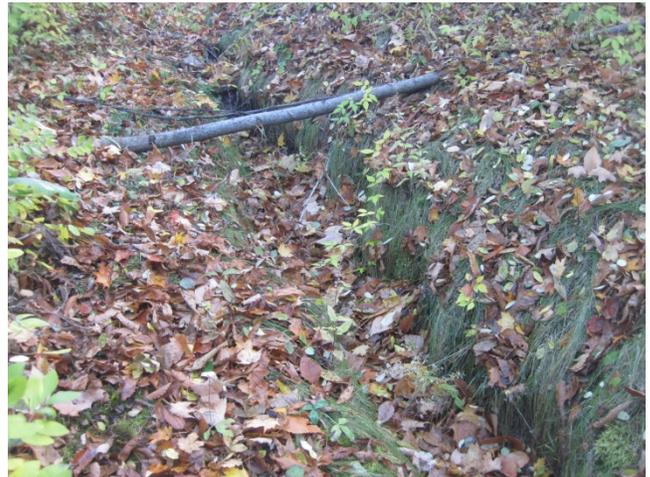
Figure 11: Active gully erosion in the cross-slope swale, partially hidden by vegetation.

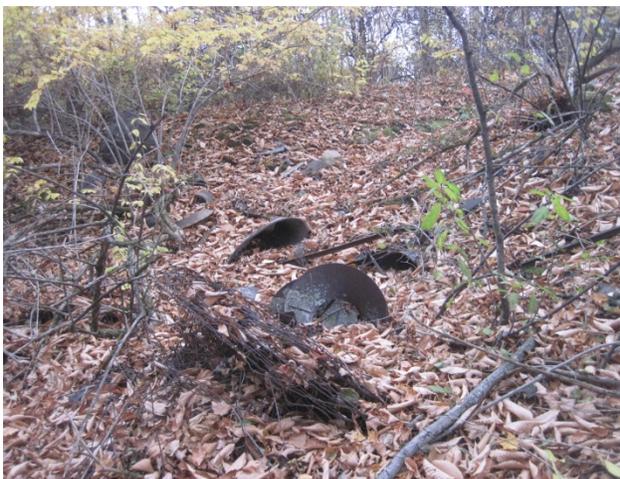
Figure 9: A small farm dump is located where the swale meets the stream.

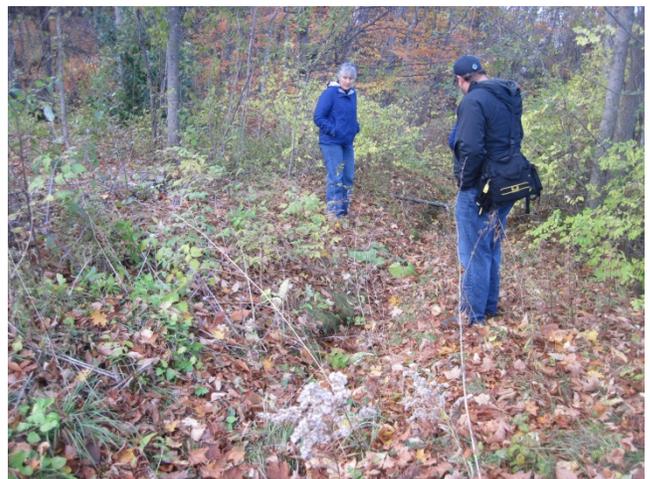
Figure 12: Gully erosion is migrating farther to the northeast along the swale (between the two people).

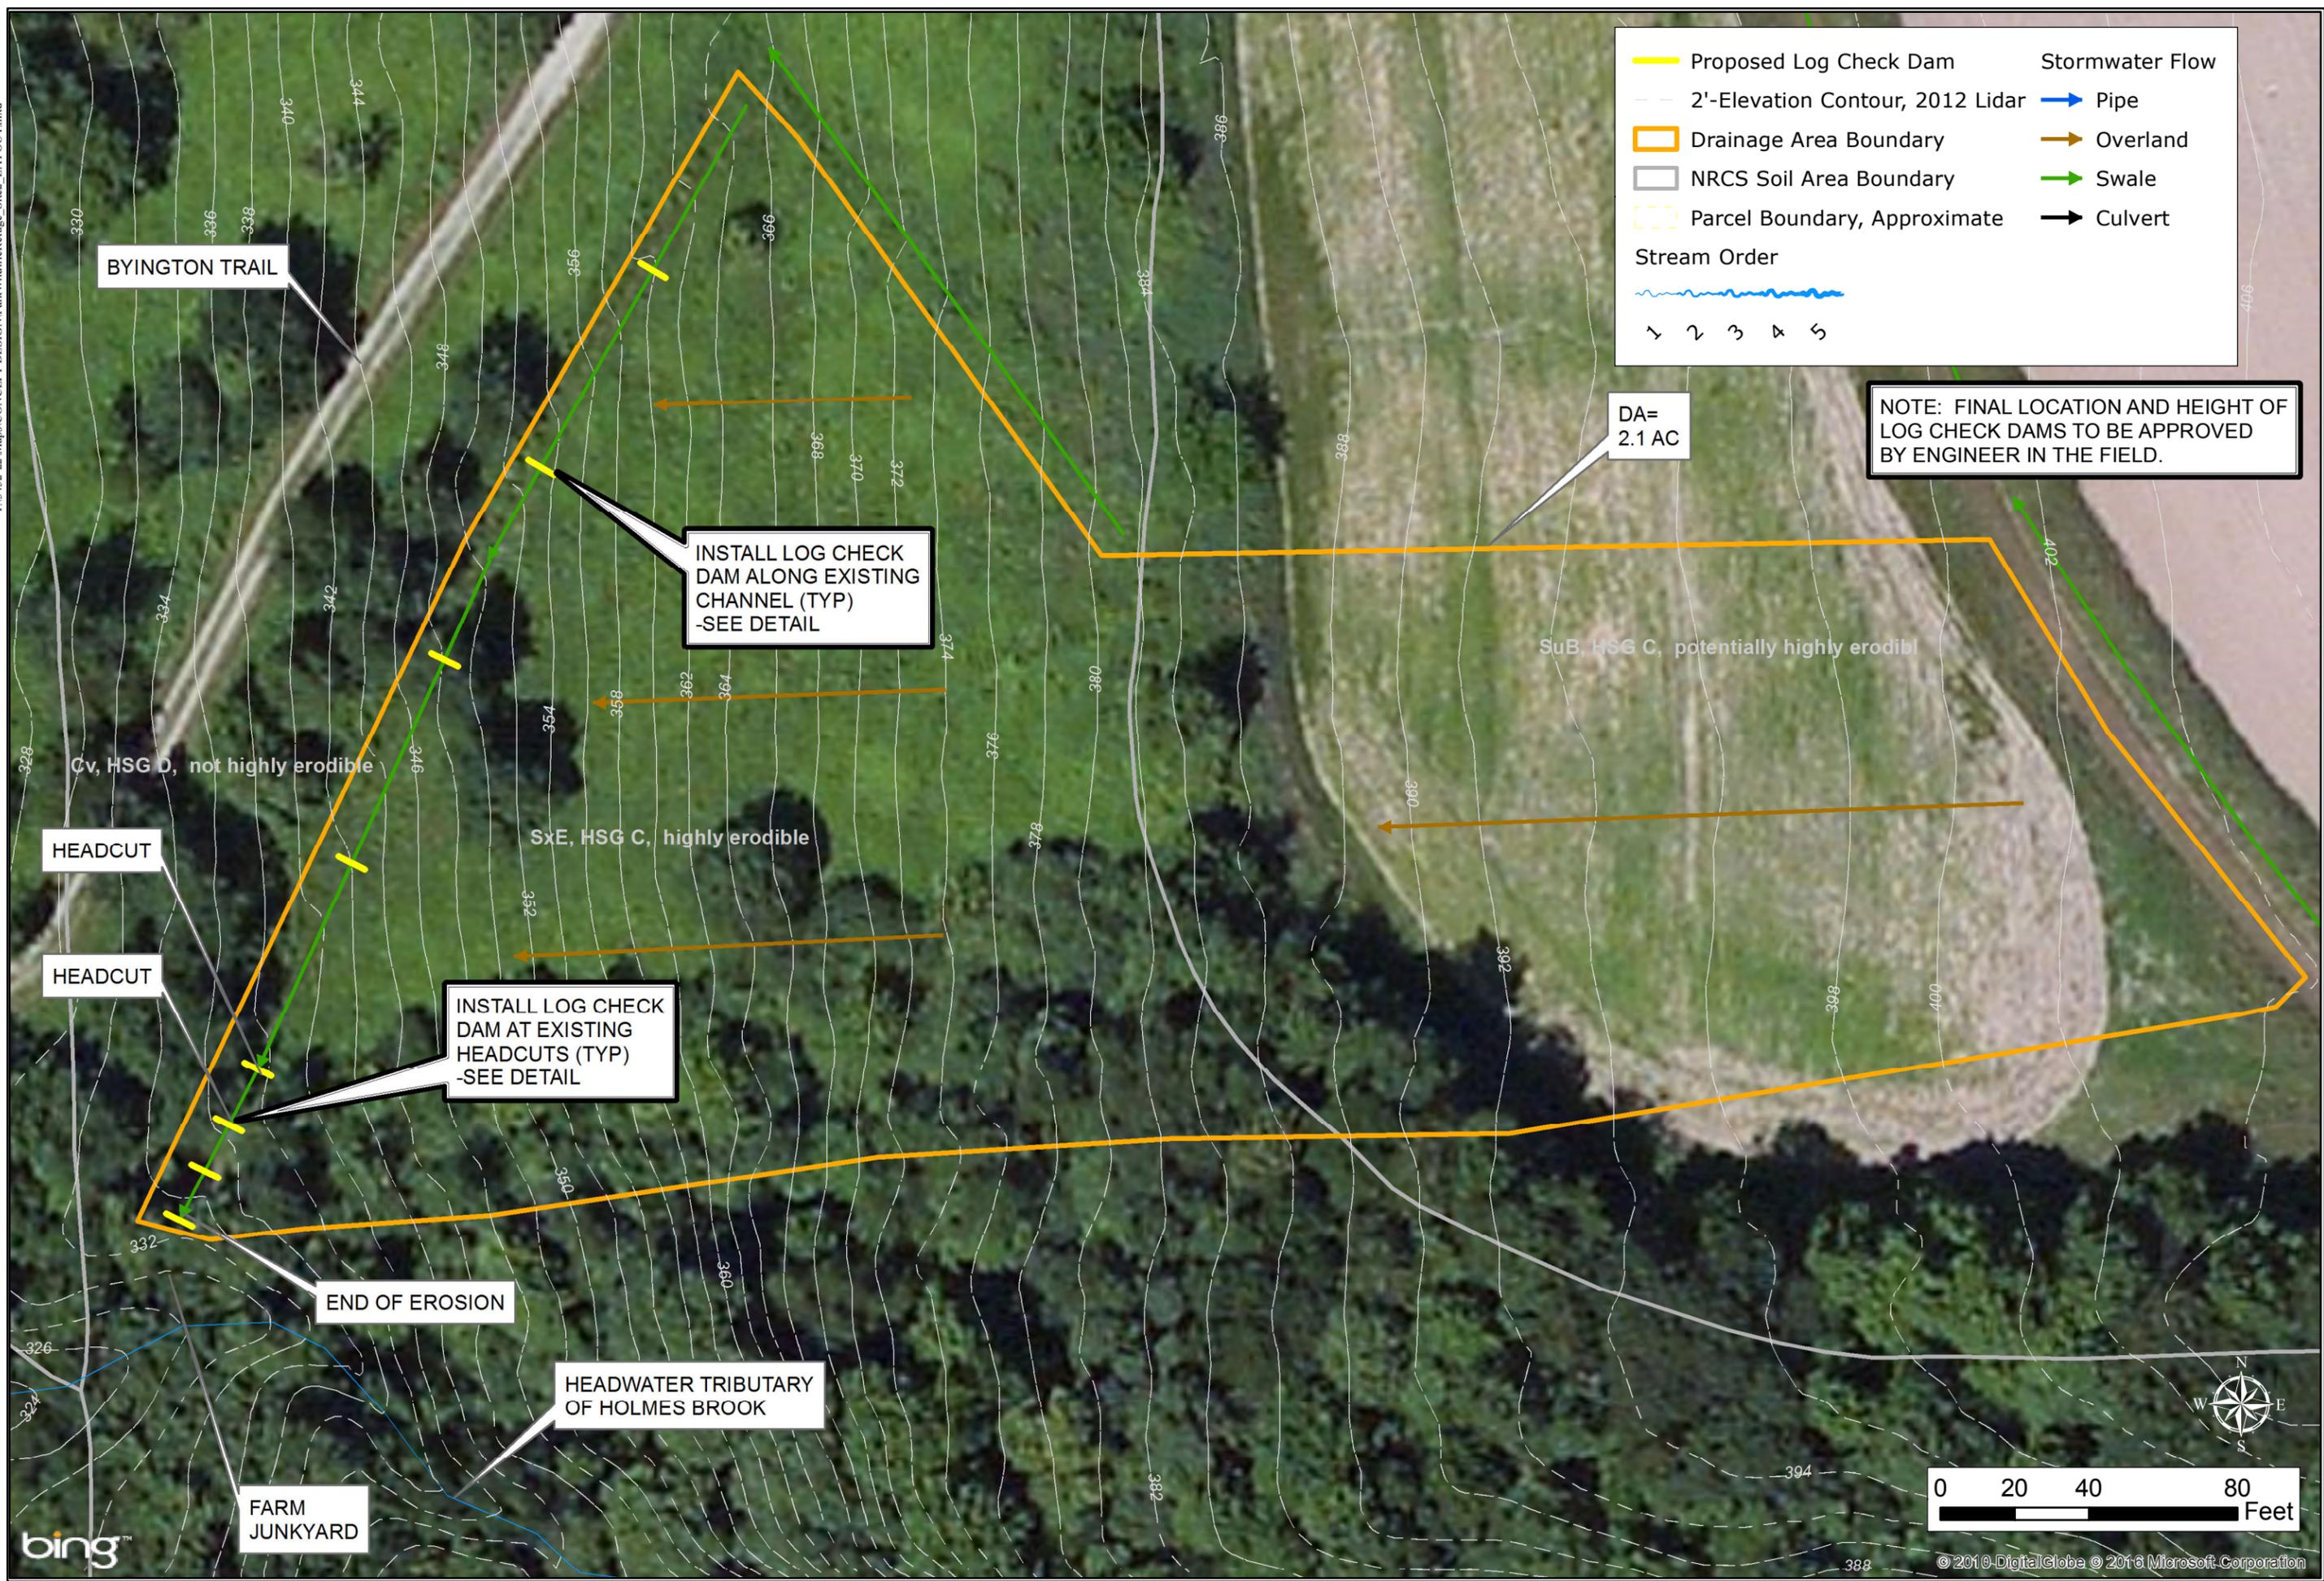
LAYOUT - SITE 2
AHEAD OF THE STORM
CHARLOTTE PARK AND WILDLIFE REFUGE
 U.S. ROUTE 7 AND GREENBUSH ROAD
 CHARLOTTE, VERMONT

HEADCUT

END OF EROSION

NOTE: FINAL LOCATION AND HEIGHT OF LOG CHECK DAMS TO BE APPROVED BY ENGINEER IN THE FIELD.

INSTALL LOG CHECK DAM ALONG EXISTING CHANNEL (TYP) -SEE DETAIL

INSTALL LOG CHECK DAM AT EXISTING HEADCUTS (TYP) -SEE DETAIL
