## Energy Audit Report

### ENERGY AUDIT REPORT – CHARLOTTE TOWN HALL:

Date: 1/27/10

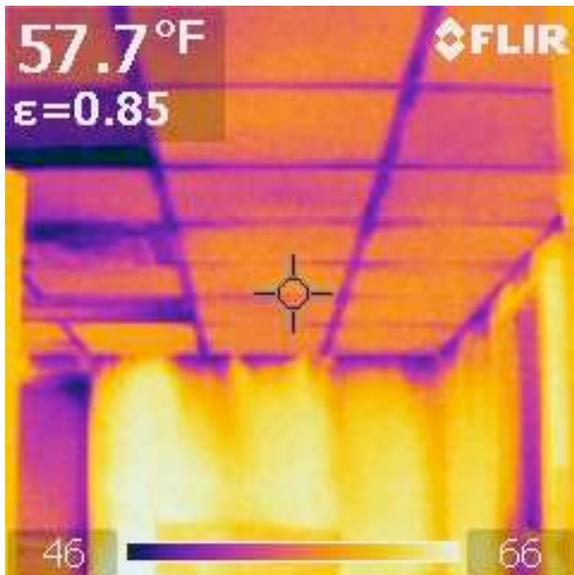
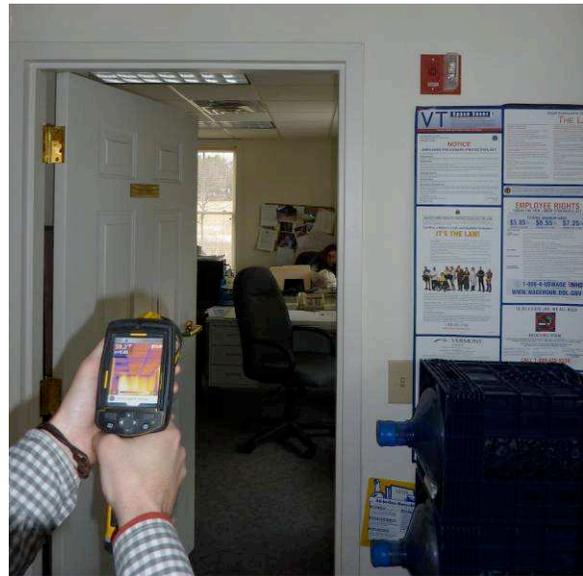
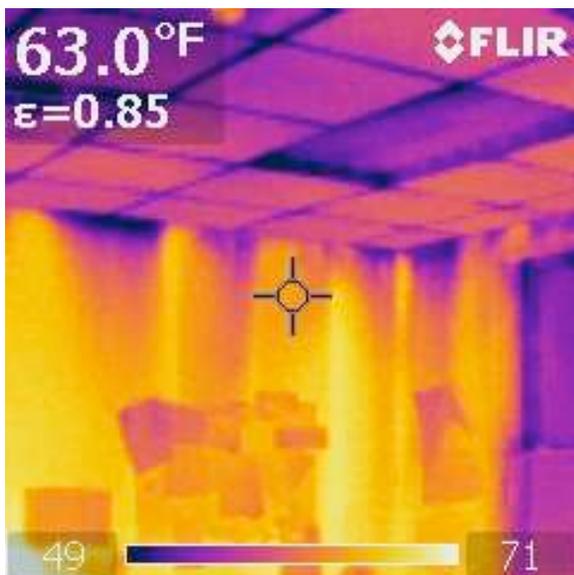
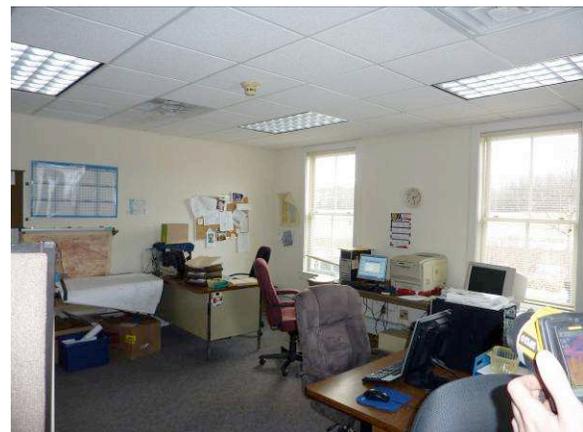
Although the attic spaces of the east and west wings are insulated, they are not air sealed. Air can easily pass between the ceiling and attic spaces. Heat loss can be seen through the acoustical ceiling tile, especially where the ceiling intersects the exterior wall. An air barrier needs to be installed.

1. \*Add an air barrier above the acoustical tile ceiling:
  - a. Remove the acoustical tile ceiling. Replace the ceiling when finished with b. and c. below. \$6,400.
  - b. Install fire taped sheetrock to the bottom of the floor joists to cover the fiberglass insulation and create an air barrier. \$5,750.
  - c. Air seal all wall plates, pipe holes, wire chases, light openings, junction boxes, duct housings sprinkler head openings, heat diffusers, and miscellaneous openings. Pay particular attention to the upper perimeter of the exterior wall in the ceiling plane and interior wall plates. \$1,280.
  - d. Save +/- 18% of heat costs.

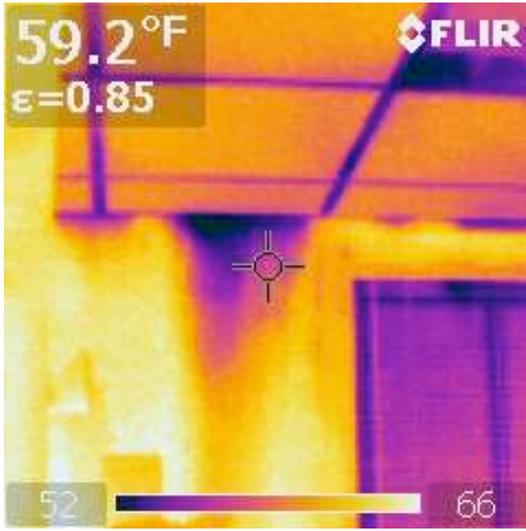
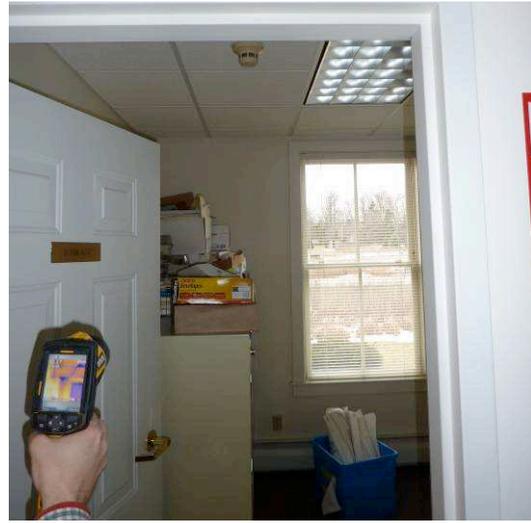
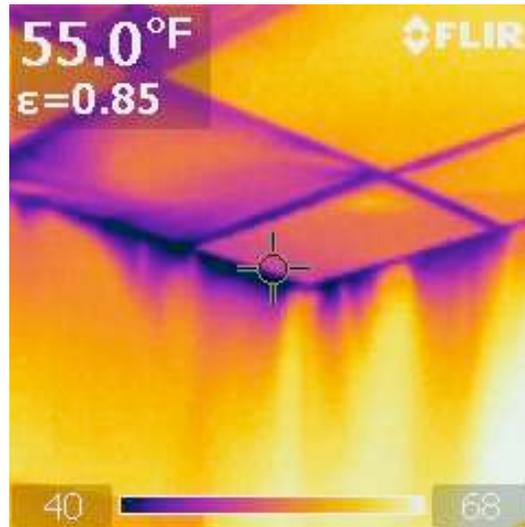
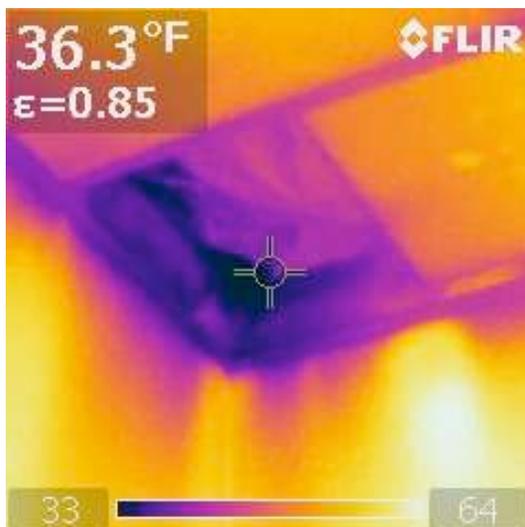
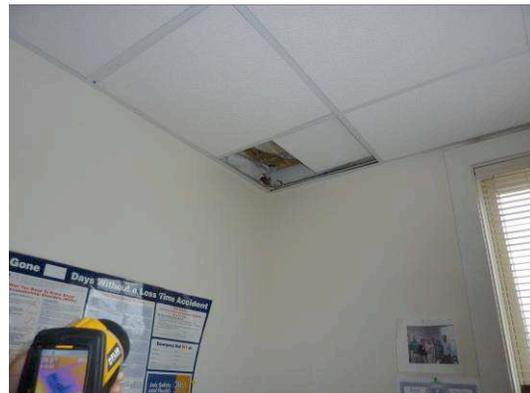
More examples of heat loss through the acoustical ceiling tile.

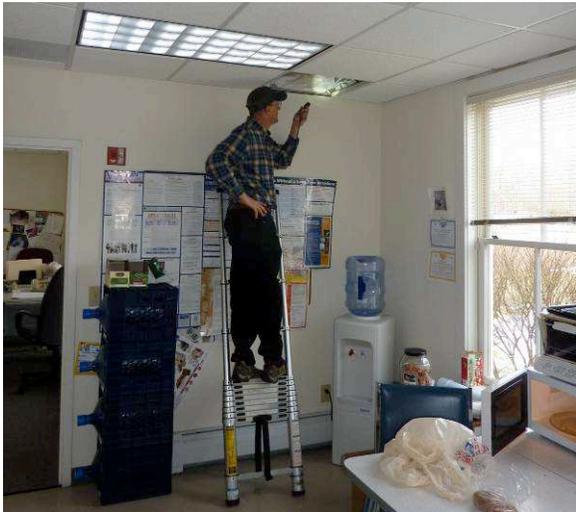
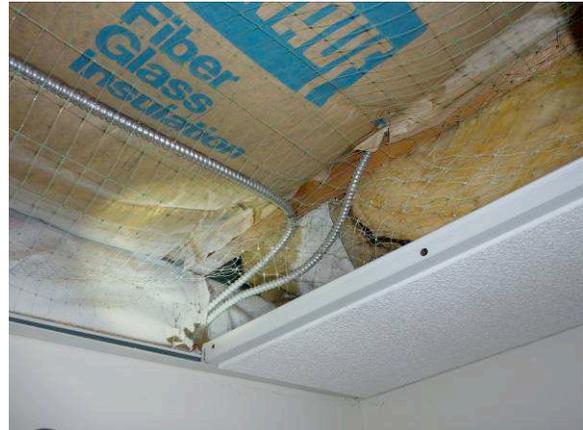
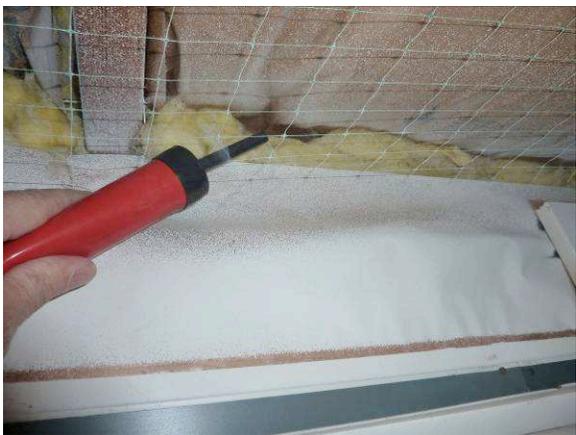
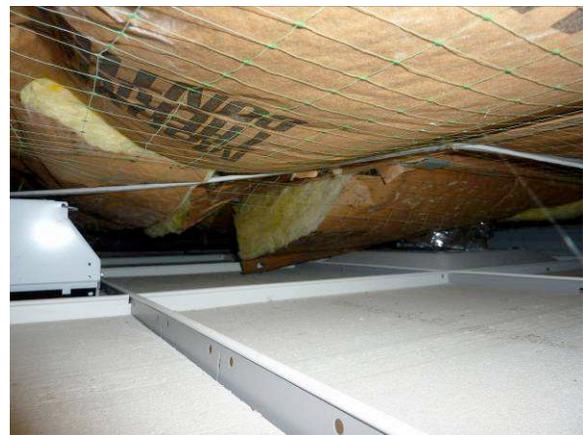
Visual inspection shows the absence of an air barrier above the acoustical ceiling tile. The fiberglass batts are held up with netting but in some areas they are falling down. Air can easily pass through the batts as shown by smoke pencil testing (bottom left).

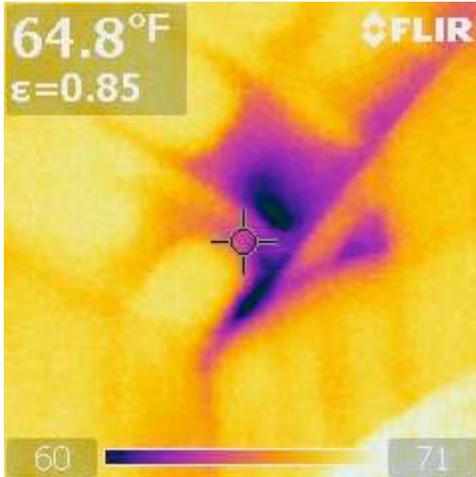
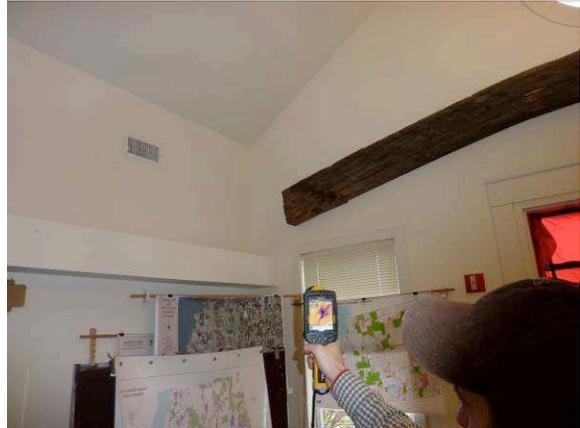
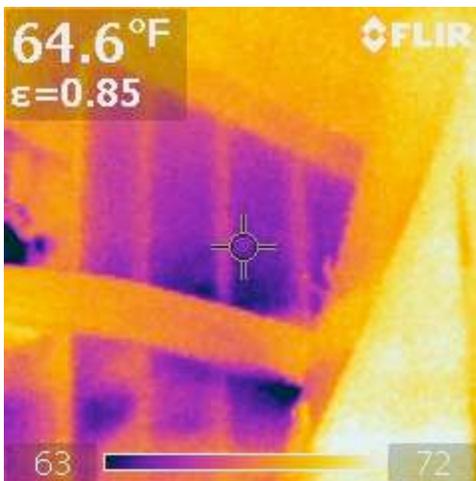
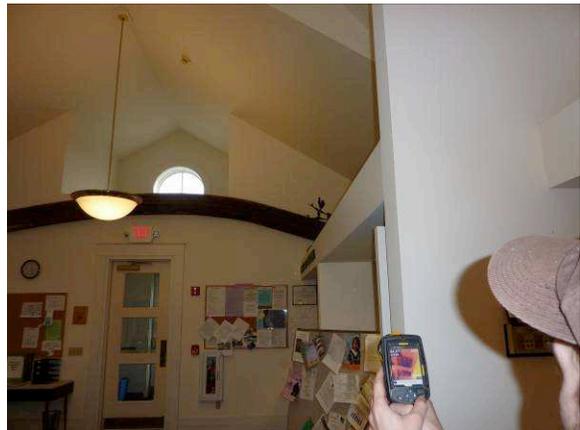
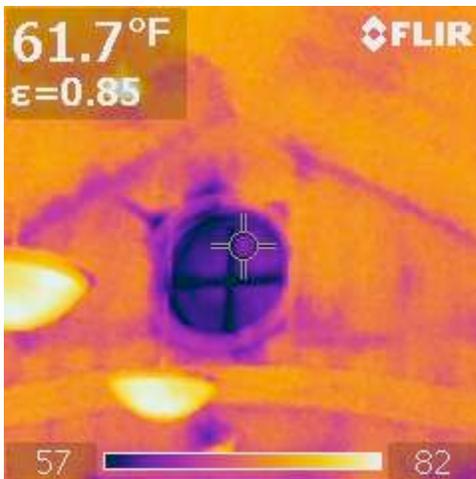
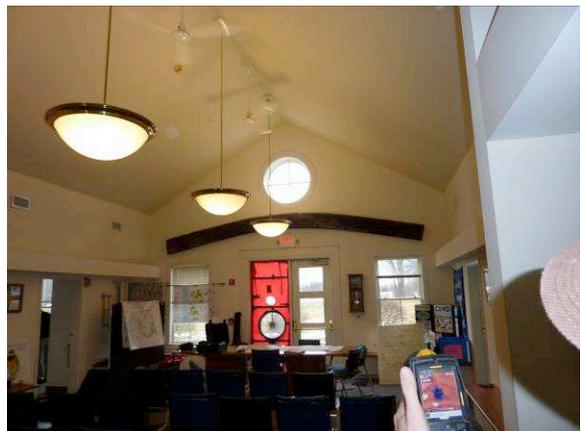
The sheetrock ceiling and kneewalls of the meeting hall provide a functioning air barrier. However, cold air from the attic can pass through the fiberglass insulation and reduce its effectiveness. Fixing the attic areas over the east and west wings are a higher priority, however, more effective insulation can be installed in the meeting hall ceiling and kneewalls. Sheetrock penetrations should be air sealed.

3. Reinsulate the meeting room kneewalls and cathedral ceiling.
  - a. \*Reinsulate the north and south kneewalls between the meeting room ceiling and the cupola: Remove the fiberglass. Install 3" of closed-cell spray foam insulation. \$850. Save +/- 1% of heat costs.
  - b. Reinsulate the meeting room cathedral ceiling: Remove the fiberglass. Install 5" of closed-cell spray foam insulation. \$11,650. Save +/- 4% of heat costs.
  - c. \*Reinsulate the kneewalls above the vestibule: Remove the fiberglass. Install 3" of closed-cell spray foam insulation. \$750. Save +/- 1% of heat costs.
  - d. Reinsulate the meeting room kneewalls: Remove the fiberglass and plastic vapor barrier. Install 3" of closed-cell spray foam insulation. \$2,750. Save +/- 2% of heat costs.

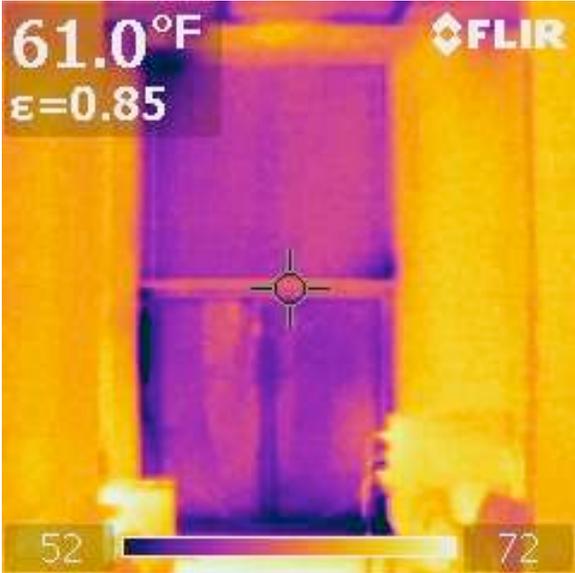
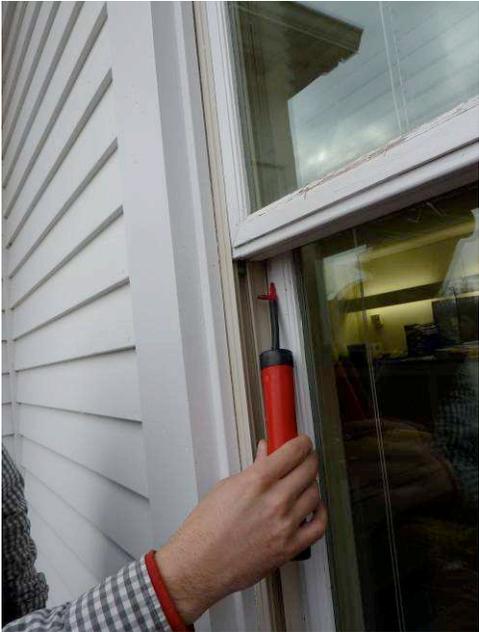
Windows are a source of heat loss. The glazing area of this building is +/- 21%, which is above average. Air leakage through the window jamb pockets can be reduced through air sealing. Windows units can be replaced and glazing area reduced in the future. Full panel storm windows can be installed in the interim.

5. In the future, replace the windows with fiberglass framed, triple glazed units. Make sure the jambs are fully insulated during the replacement process. Reduce glazing area to 15% by eliminating some low priority windows. Budget \$1,000 per opening, total 28 windows. Save +/- 7% of heat costs. In the interim, install full panel storm windows (\$225 each) and save +/- 3% of heat costs.

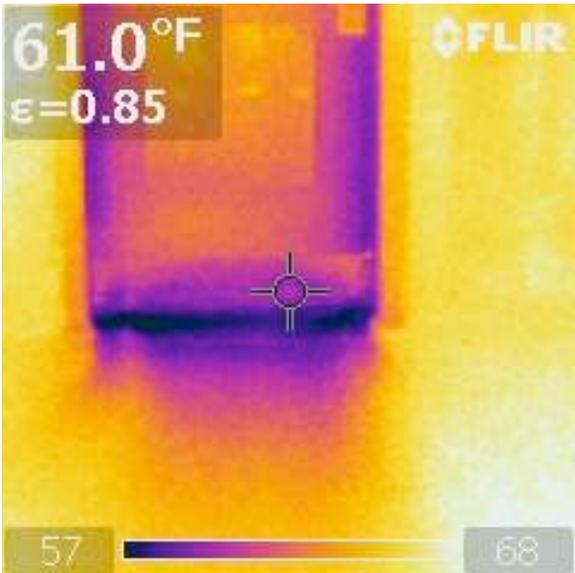
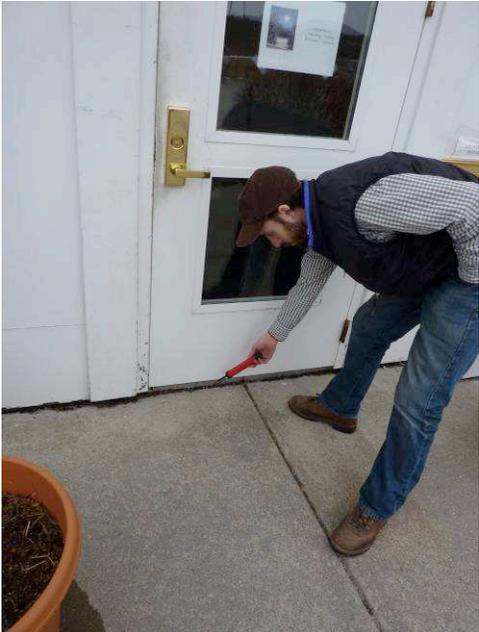
Like windows, doors are a source of heat loss. We recommend maintaining the weatherstripping on all exterior doors.

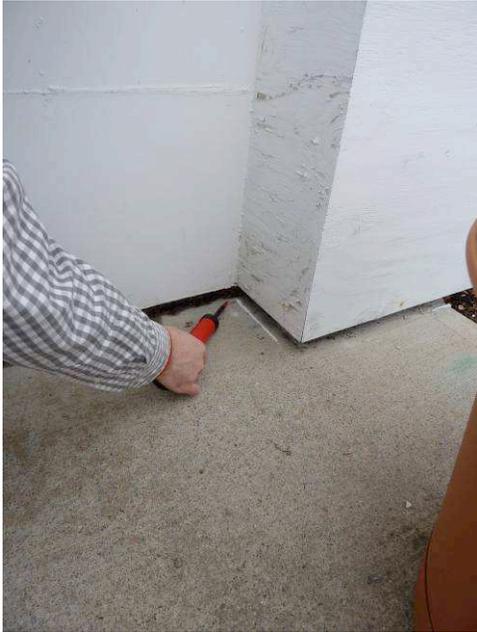
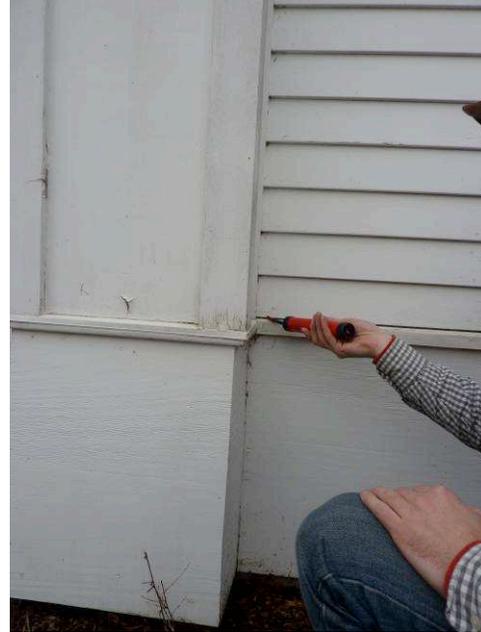
Air leakage is present at exterior wood to concrete seams and building transitions. These areas should be air sealed.

4. Blower Door Directed Air Sealing: It is recommended to perform up to 16 hours of blower door directed air sealing of: door weatherstripping, exterior wall siding transition to concrete, exterior wall building transitions, bathroom fan dampers, and window jamb pockets. \$960. Save +/- 1% of heat costs.

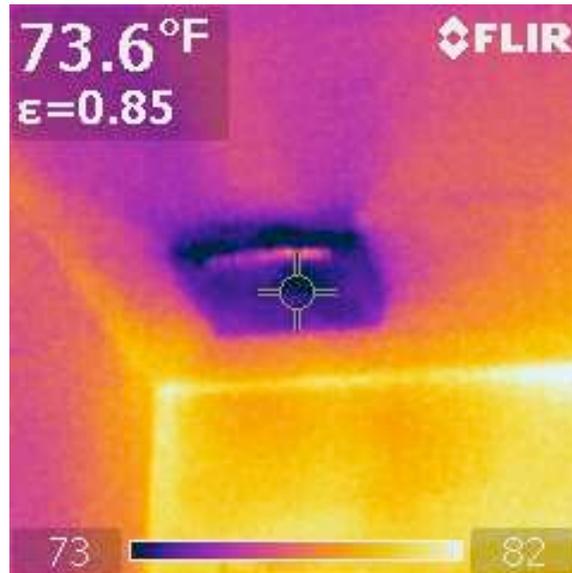
The bath fan dampers may not be installed or functioning properly. Dampers reduce heat loss when the fan is not operating.

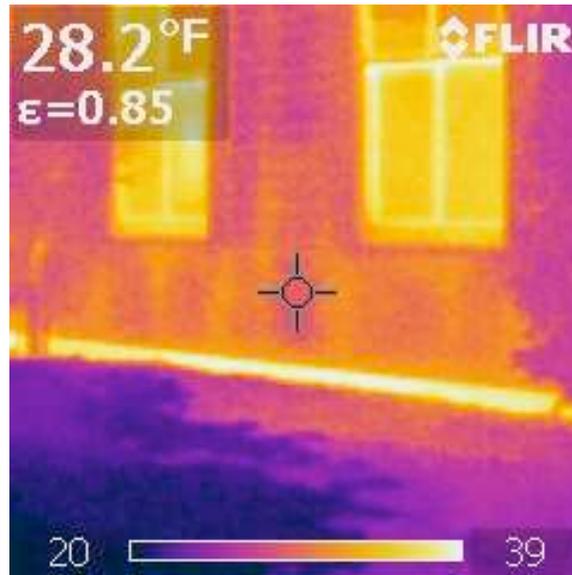
There is heat loss at the slab edge. Rigid insulation can be added in the future.

6. In the future, add foundation insulation at the exterior slab wall where possible to reduce heat loss. Install 2" of extruded polystyrene insulation to all above grade foundation areas and join to the existing below grade insulation (if present). Protect the above grade insulation with a non-water sensitive material (ex. stucco). \$30 per square foot. Save +/- 7% of heat costs.

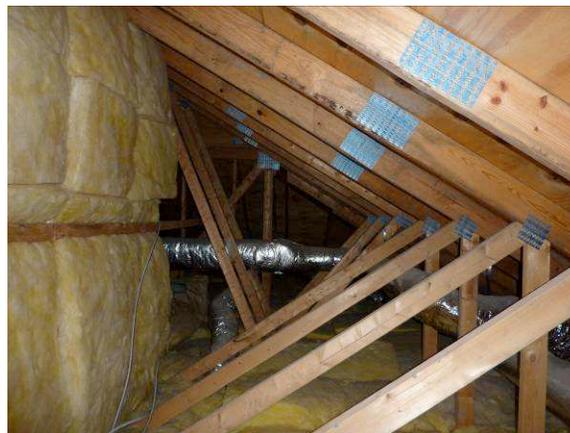
The air conditioning ductwork is covered with R-5.4 insulation. Despite this, there are distribution losses that result from locating the ductwork in an unconditioned attic space.

9. Air Conditioning / Ventilation Recommendations: Repairs/adjustments to the system should follow the thermal envelope improvements. It may be possible to reduce the size of the equipment once the heating and cooling load is reduced.
  - a. Install ductless mini-spliters and discontinue use of the air conditioning duct system.  
OR
  - b. Replace the air handlers with energy recovery ventilators (ERV) in order to provide fresh air intake and recapture energy from the conditioned building air. +/- \$5,000 per unit.
  - c. Insulate all ductwork in the unconditioned attic space with spray foam to R-24.
