Introduction

Purpose and Need Statement

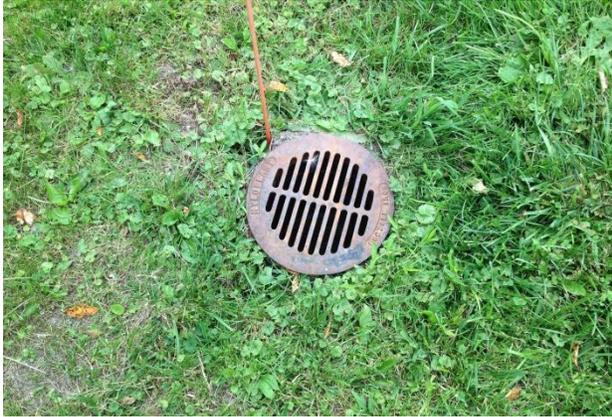
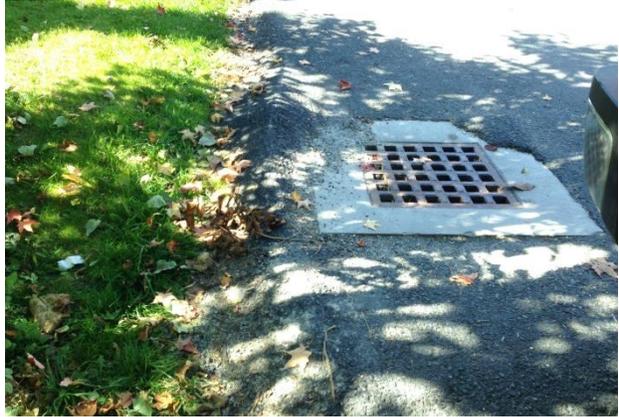
Undersized drainage inlet (left); Pavement grading inhibits water from entering drainage inlet near Greenbush Road (right)

Catch basins should be replaced or installed in the raingarden locations; at least one additional catch basin should be replaced and regarded to allow more effective entry of stormwater into the pipe network.

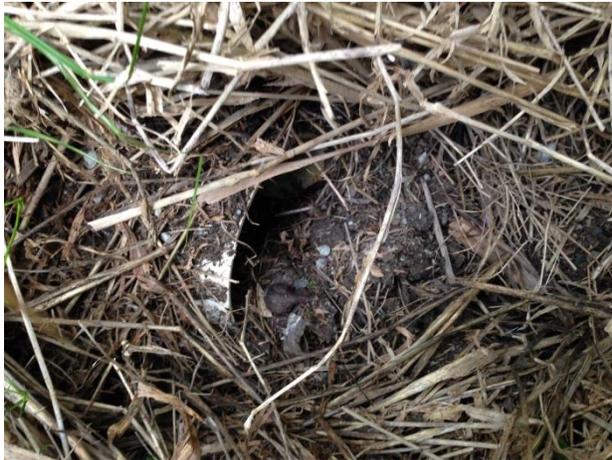
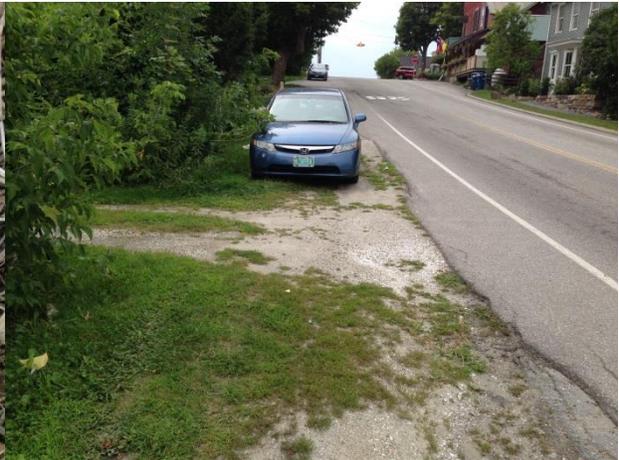
blocked culvert entrance adjacent to Post Office (left); Signs of erosion along southerly road edge across from and east of the Old Brick Store (right)

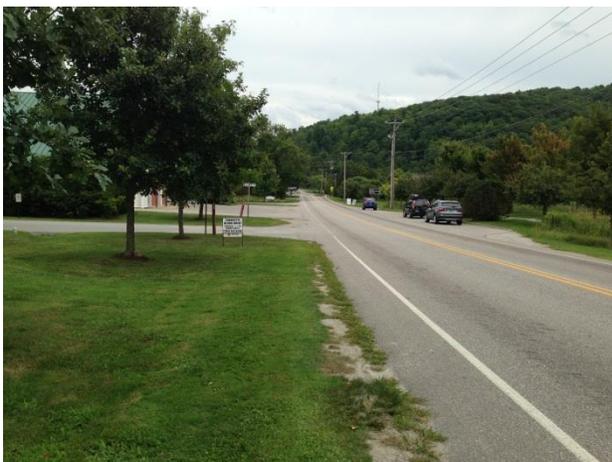
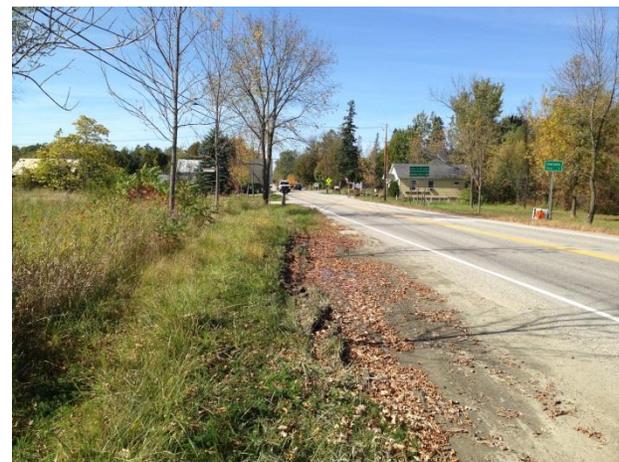
Gravel berm preventing sheet flow on north side of Ferry Road (left); Ponding evidence at low spot near US Route 7 on south side of Ferry Road (right)

The low spot on Ferry Road as it approaches US Route 7 routinely ponds water. This could be addressed with a bioswale along the edge of the US 7 shoulder, with an underdrain to the wetland, which would store and treat runoff from Ferry Road before it enters the adjacent wetland. The figures below show a typical bioswale cross section (left), and an example of how a bioswale can be integrated into a future pedestrian project, if eventually a sidewalk is constructed to US 7 (right).

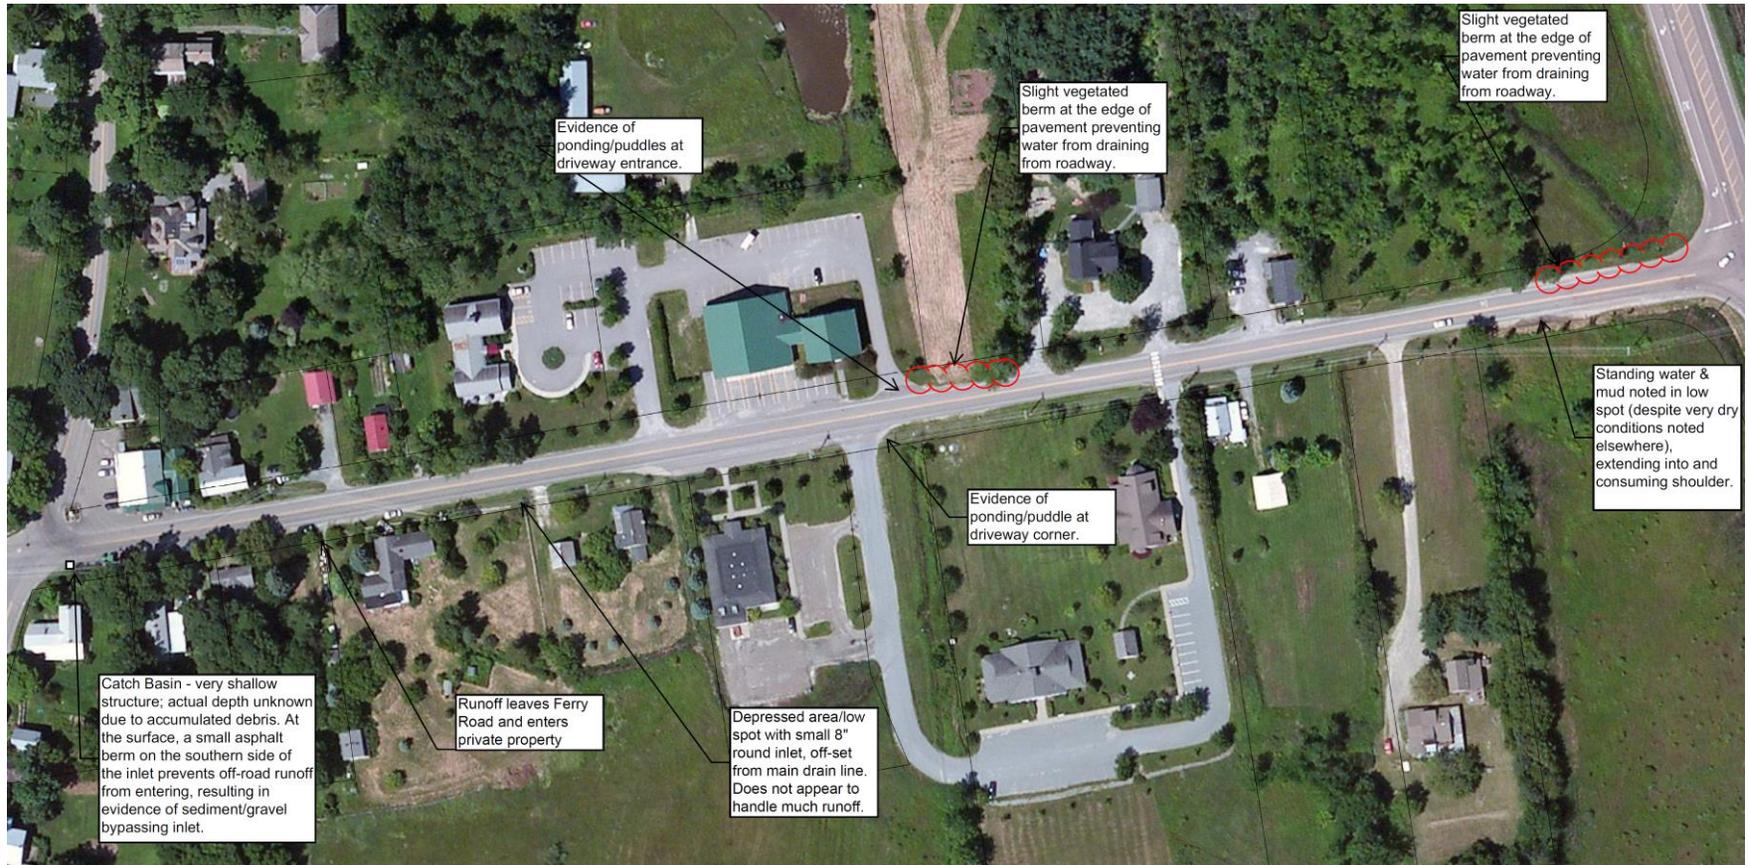
Figure 3: Stormwater Issues and Opportunities (D&K Observations, July 2014)

The 2011 Master Plan for Mobility provided mapping and field observations on stormwater patterns as depicted in Figure 2. In addition, DuBois & King conducted two site visits and field surveys in August of 2014, with the observations and findings summarized in Figure 3. Flow conditions were also observed by town officials in November, 2014, with the assistance of the Charlotte fire department, which poured water from its tanker truck at the intersection of Ferry and Greenbush Roads. It was confirmed that a continuous 15 inch pipe runs along the south side of Ferry Road from the Greenbush intersection to the ditch east of the Town Offices driveway. There are two visible drainage inlets, but they are undersized or not properly graded so that runoff is not collected effectively. In addition, there is a private drainage pipe running south from Ferry Road between the Post Office property and the adjacent residential property to the west, which is not functioning, and may require cleaning or maintenance.

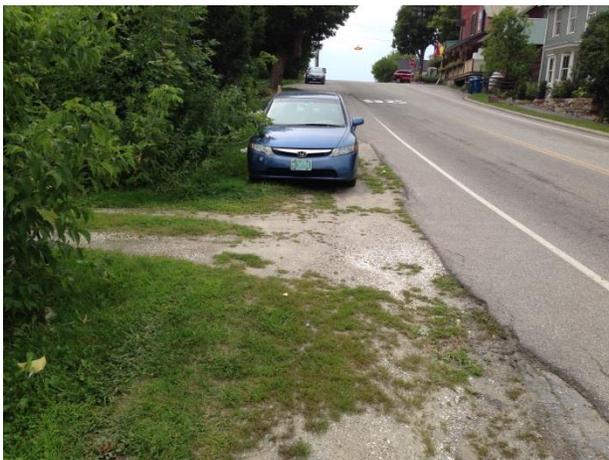
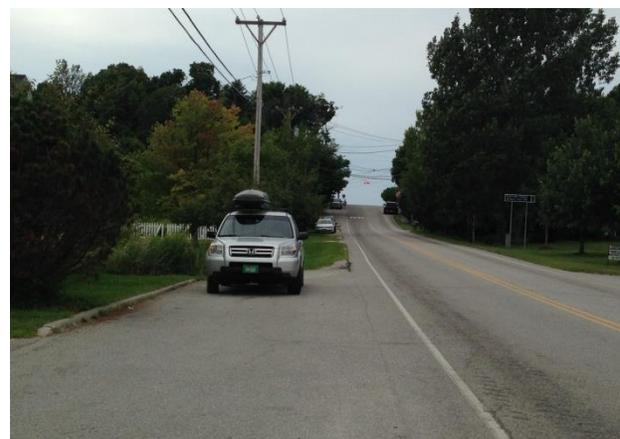
Parking on gravel shoulders may exacerbate erosion (left); on street parking by Post Office provides 4 feet buffer between cars and travel lanes (right)
