Cemetery Commission of Charlotte, Vermont
PROPOSED FY2018 BUDGET

Submitted by Viki Zulkoski, November 8, 2016

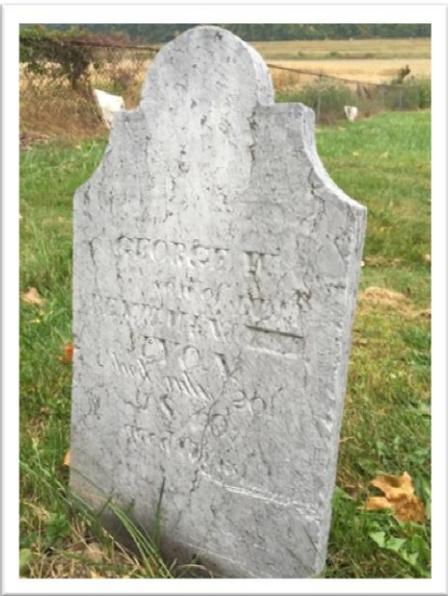
Photo #1, Light damage, weed whacker

G/L Code	Account Title	\$	Explanation	Reference
1000	Grounds Maintenance <ul style="list-style-type: none"> • Mowing \$4,400 • Weed Whacking \$1,600 	\$ 6,000	Additional cost to adhere to industry standard of mowing practices for antique cemeteries	Table 1, Photos 1-3
2000	Fence Repair/Replacement <ul style="list-style-type: none"> • 368 ft X \$40/ft \$14,720 • Two Gates \$ 1,000 	\$15,720	Replace the chain link fence, front section only, West Burying Ground	
3000	Research/Mapping	\$ 500	Mapping and further research in West Burying Ground	Photo 4
4000	Tree Work/High Trimming	\$ 1,500	Tree work including preventative cabling if necessary	
5000	Headstone Repair <ul style="list-style-type: none"> • Quote from Jeff Kuhn, Kuhn Memorials 	\$ 5,000	Stone repair is ongoing and difficult or impossible to estimate, Jeff Kuhn puts to total to repair the West Burying Ground in excess of \$50,000	Table 2,3

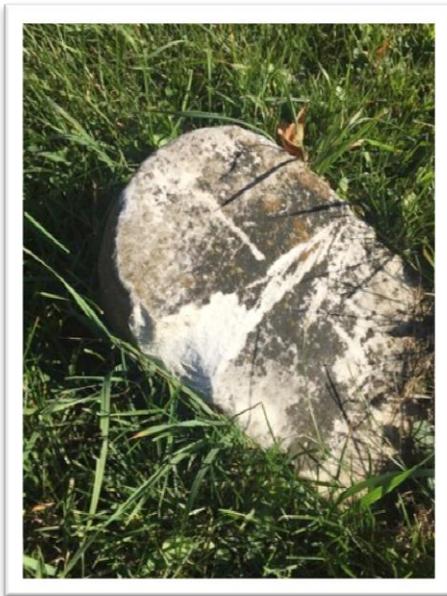
Photo #2, Fallen stones are particularly vulnerable to mowing damage

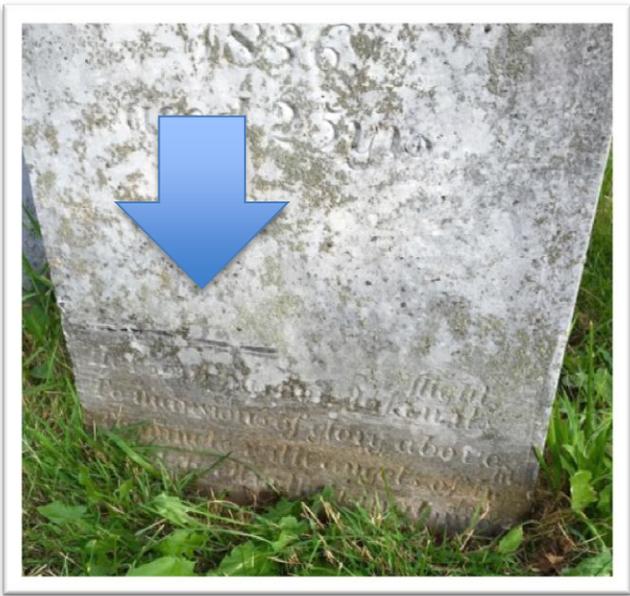
Photo #3, damage from weed whacking and skid marks from mower tires

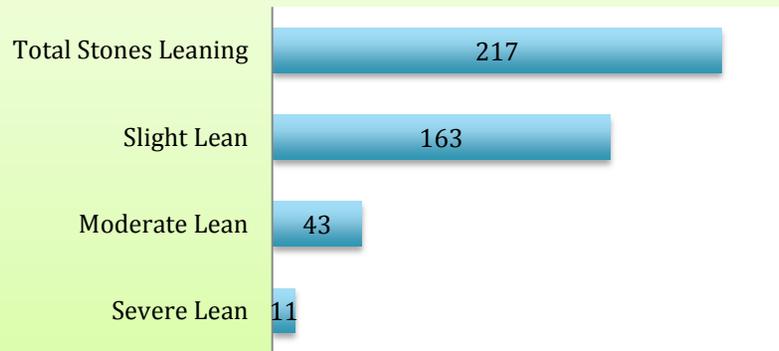
Table #2

Leaning Stones, West Burying Ground

Because they will likely break upon impact, Vermont Old Cemetery Association (VOCA) recommends that leaning stones are repaired before stones which are already broken.

The cost to correct a leaning stone can vary from \$50 - \$150 per tablet vs. a cost of \$500 each to repair a broken stone. Larger memorials are assessed on a case by case basis.

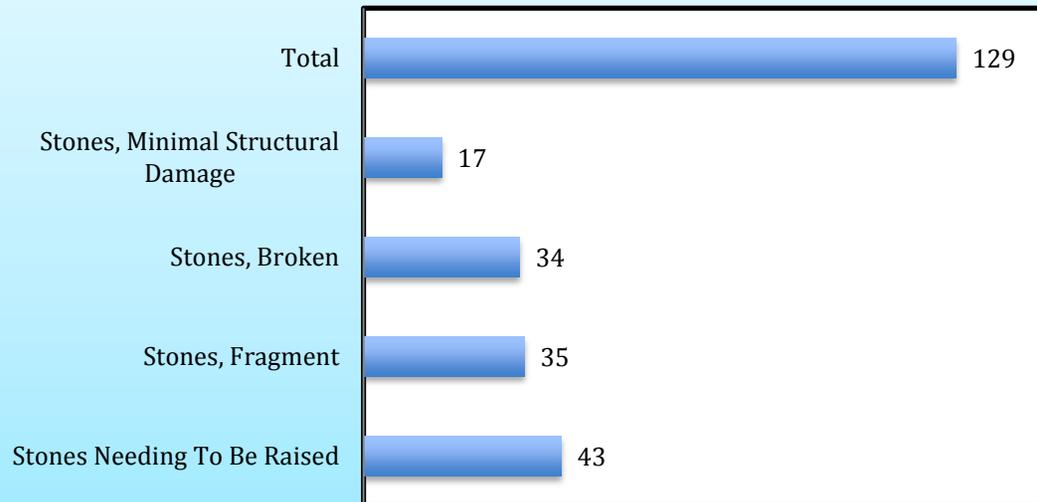
Table #3

Stones Needing Repair

These estimates are an average and actual costs can vary widely.

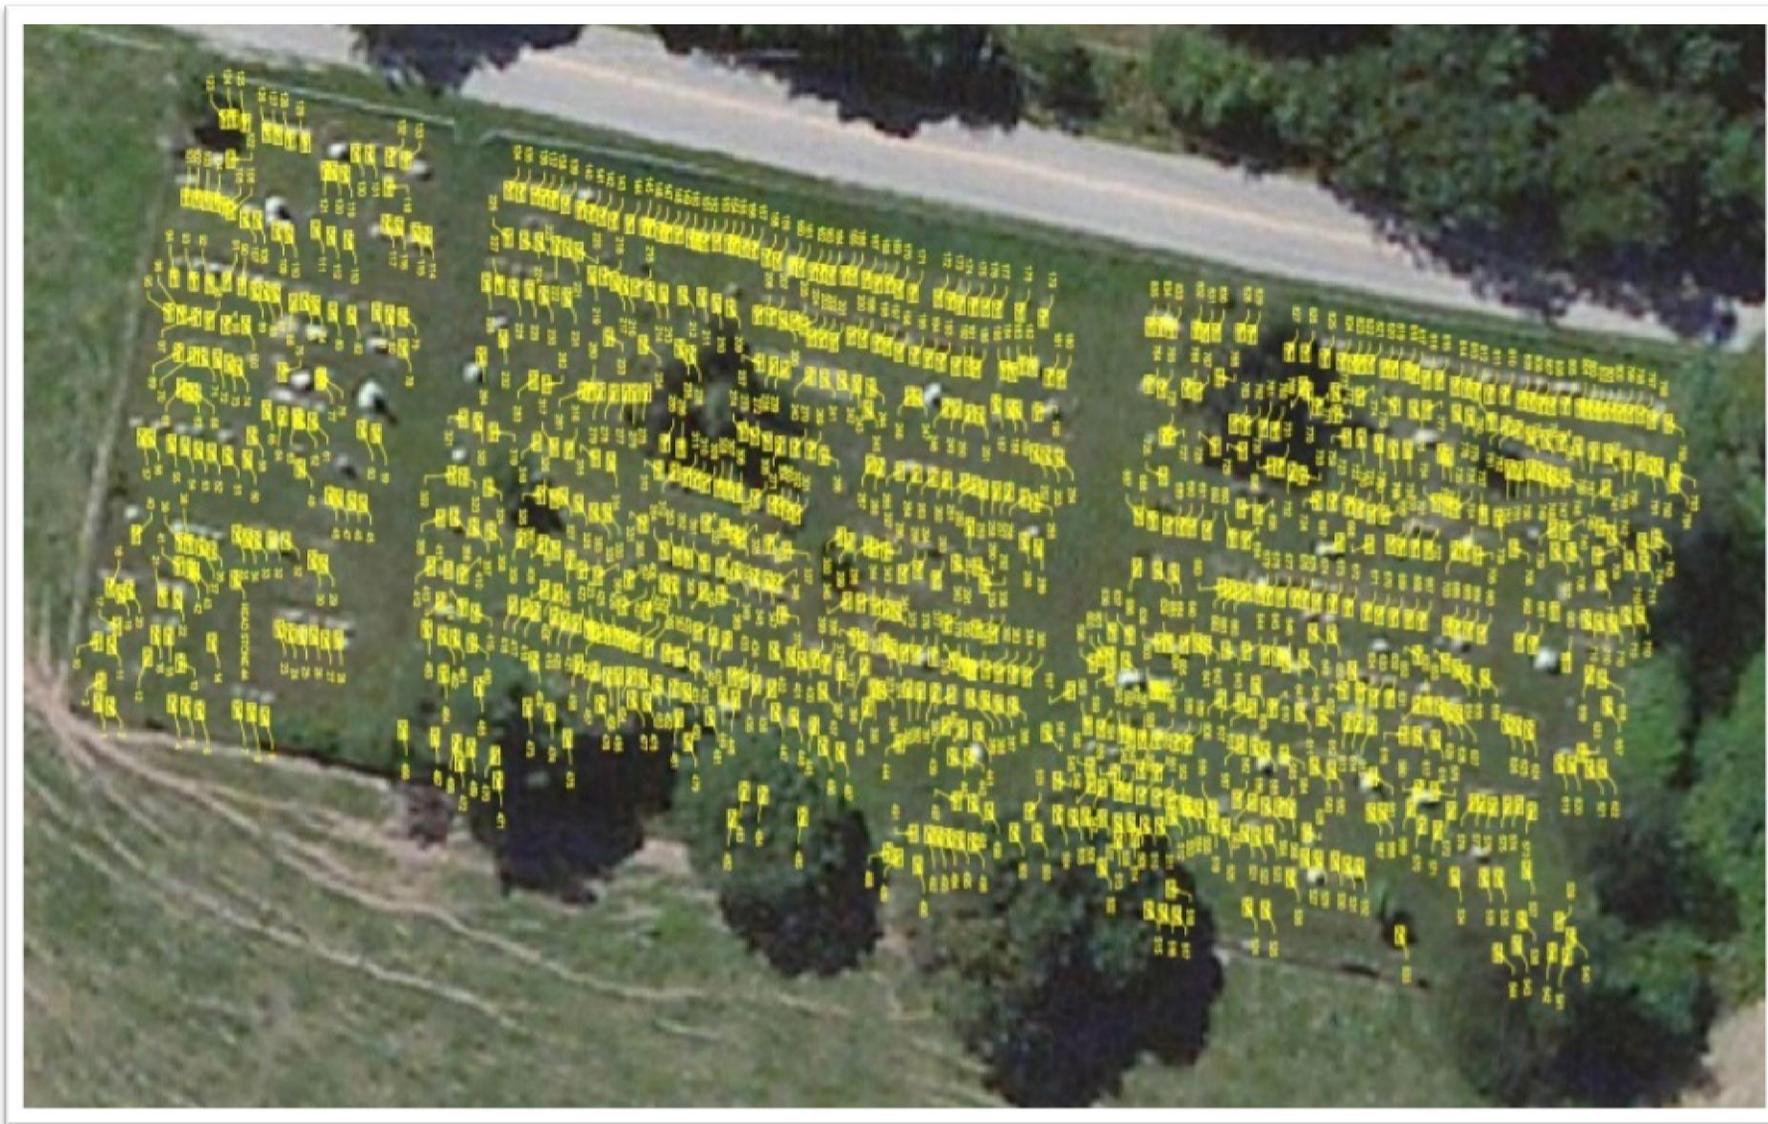
Photo #4 – Aerial View of West Burying Ground Penetrating Radar Findings
835 human remains in total, over 100+ more than previously recognized
